Sample Community Association

Level 1 Reserve Study

Client Reference Number	10014
Property Type	Condominium
Number of Units	150
Fiscal Year End	12/31
Type of Study	Full Study
Date of Site Visit	4/16/2023
Prepared By	Robert Forney
Analysis Method	Cash Flow
Funding Goal	Full Funding

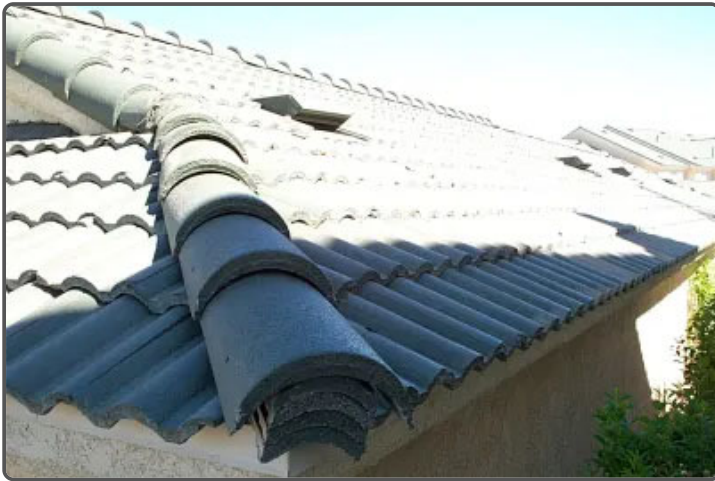
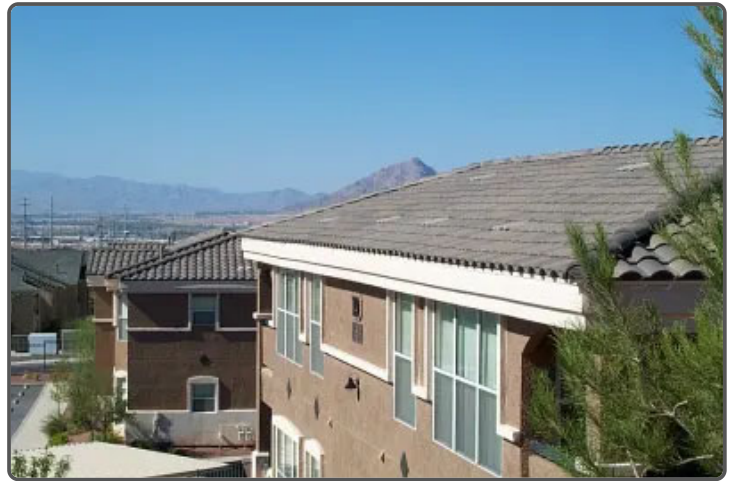
Comp # 106 Pitched Roof - Tile - Replace

No problems noted or reported. Tile roofs have a typical life expectancy of approximately 25 to 30 years before underlayment deterioration causes significant leaks. Inspect roofs regularly and make repairs as necessary as an operating expense to ensure full life. Remaining life based on current age.

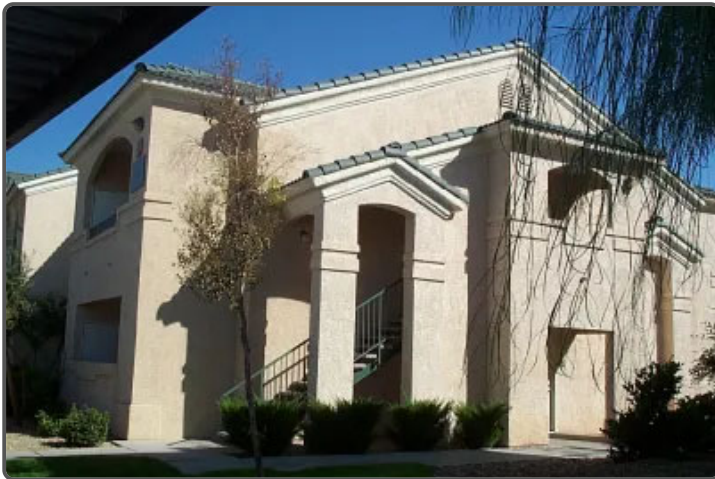
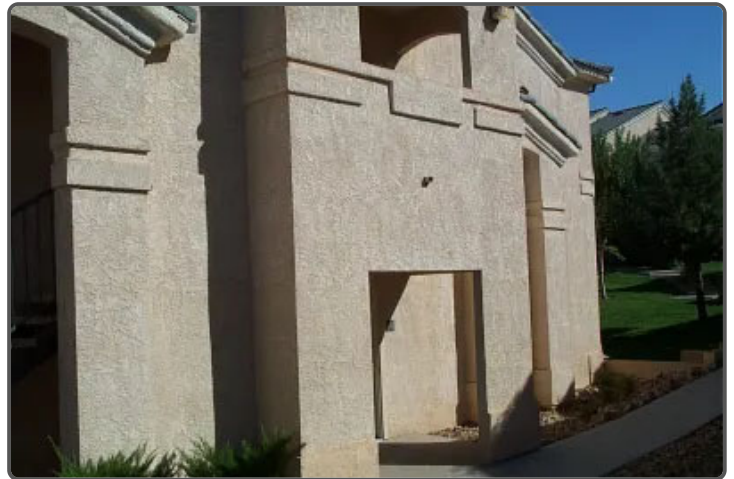
Comp # 201 Stucco Surfaces - Repaint

Painted stucco surfaces are generally in good to fair condition. Some staining and discoloration noted in local areas. Stucco surfaces should typically be repainted approximately every 10 to 12 years to protect stucco surface and maintain appearance. Remaining life based on current condition.

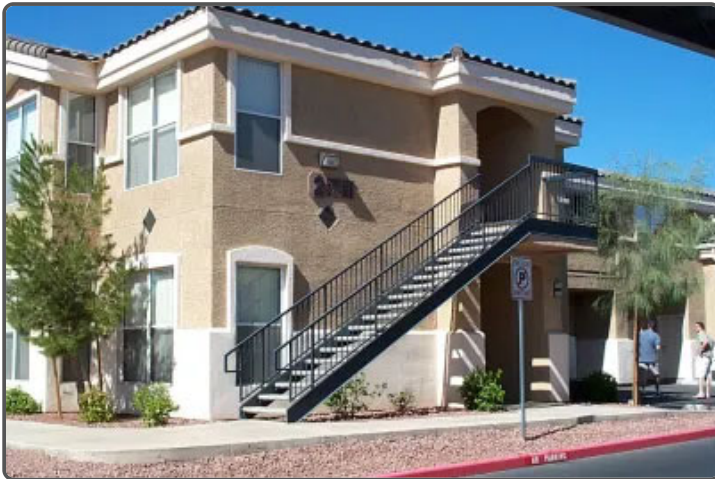
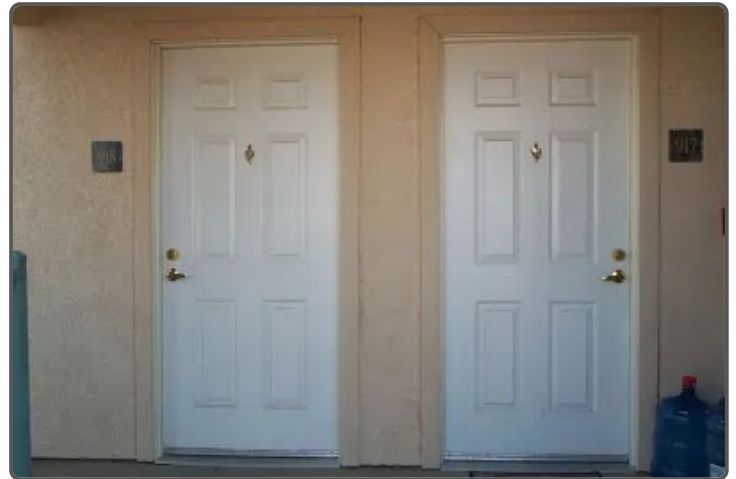
Comp # 202 Building Trim - Repaint

50 Linear ft. - 8 Unit Building Handrails (Painted with building exteriors)
250 Linear ft. - 11 Unit "A" Building
300 Linear ft. - 11 Unit "B" Building
150 Front doors

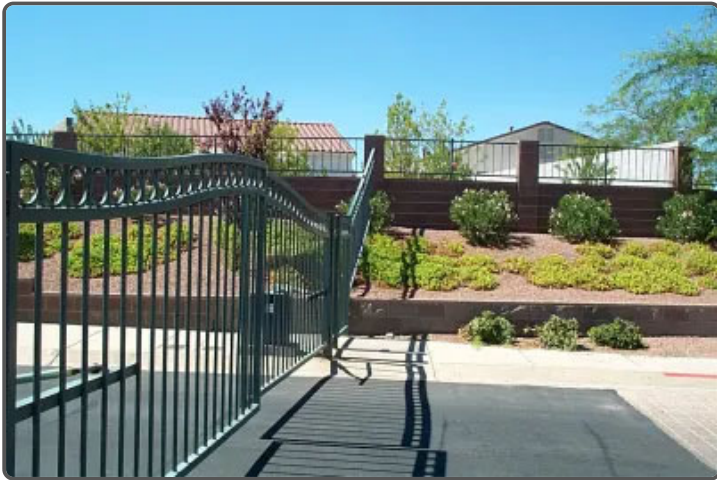
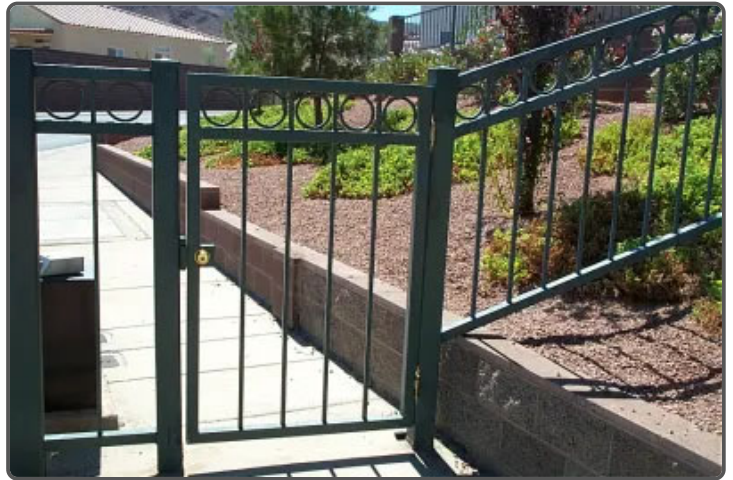
Comp # 206 Vehicle Gates - Repaint

Painted gate surfaces are in good condition. No significant paint loss or appearance concerns noted. We recommend funding to repaint these gates approximately every 3 to 5 years. Remaining life based on current condition.

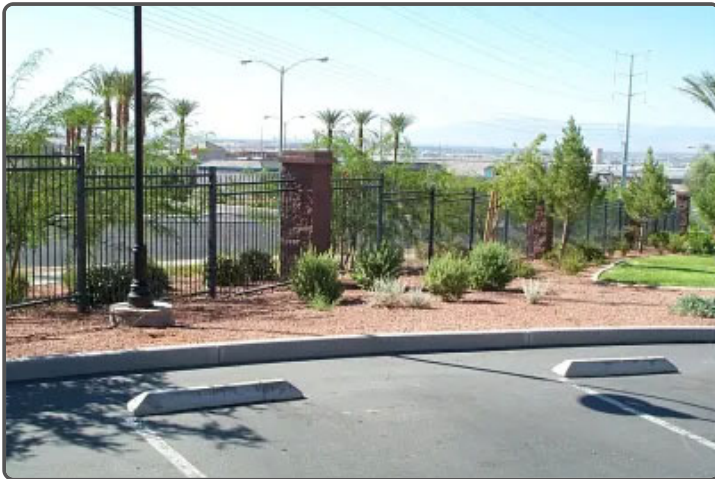
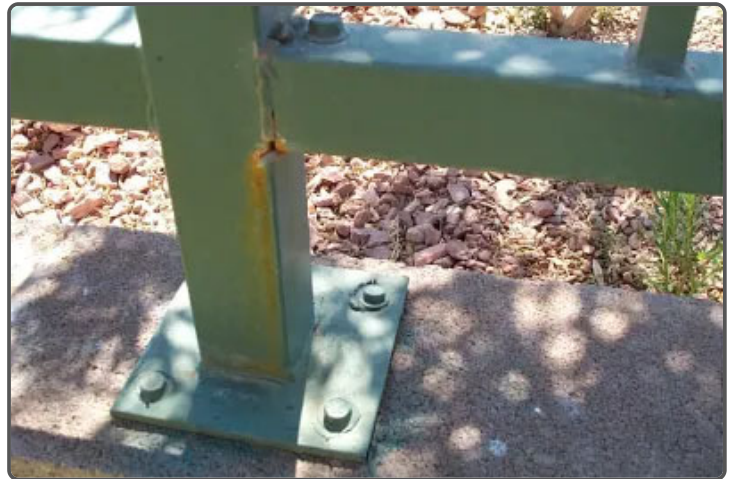
Comp # 207 Wrought Iron Fencing - Repaint

50 Linear ft. - Entry area
250 Linear ft. - Pool area
1,500 Linear ft. - Perimeter fencing
1,800 Linear ft. - Total

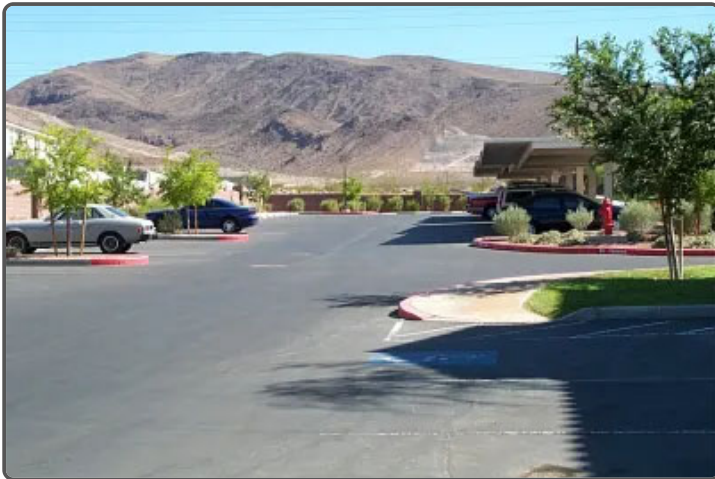
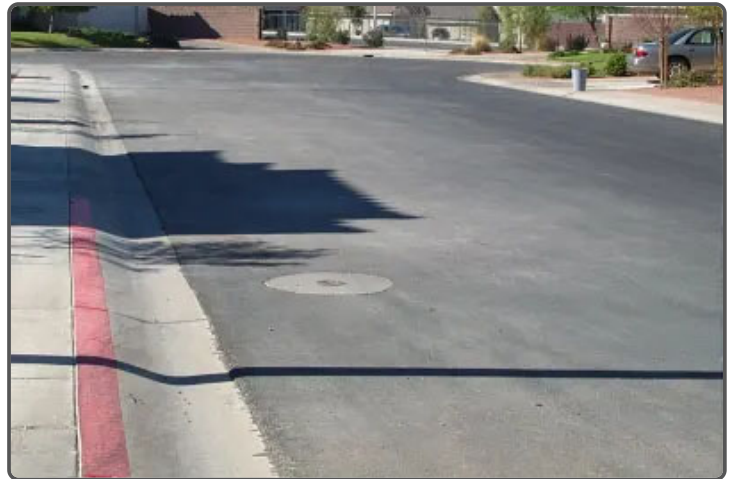
Comp # 401 Asphalt - Major Rehab.

15,350 Sq.ft. - Augusta Ave.
15,775 Sq.ft. - Blackridge Ave.
9,625 Sq.ft. - Copper St.
33,750 Sq.ft. - Webster Ave

74,500 Sq.ft. - Total

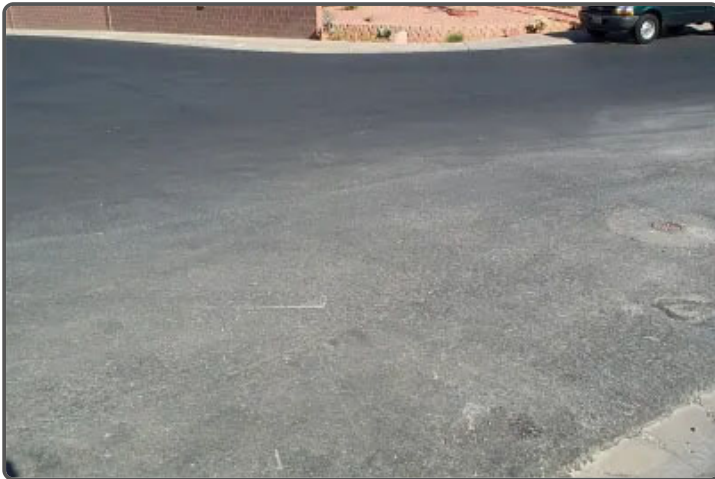
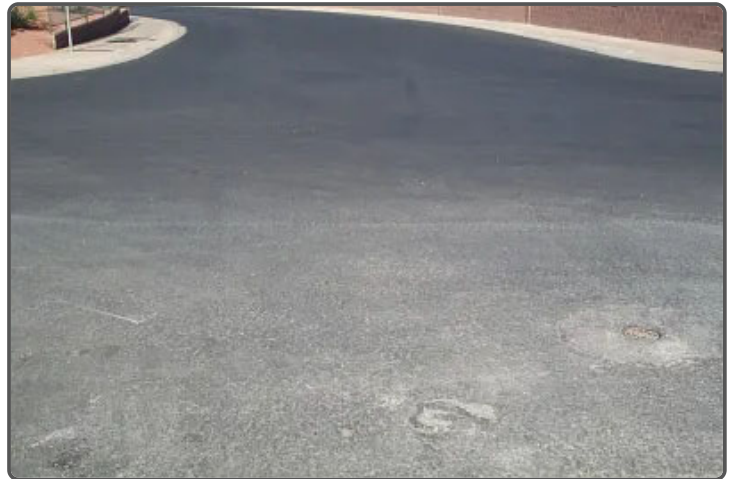
Comp # 402 Asphalt - Preventative Maintenance

15,350 Sq.ft. - Augusta Ave.
15,775 Sq.ft. - Blackridge Ave.
9,625 Sq.ft. - Copper St.
33,750 Sq.ft. - Webster Ave

74,500 Sq.ft. - Total

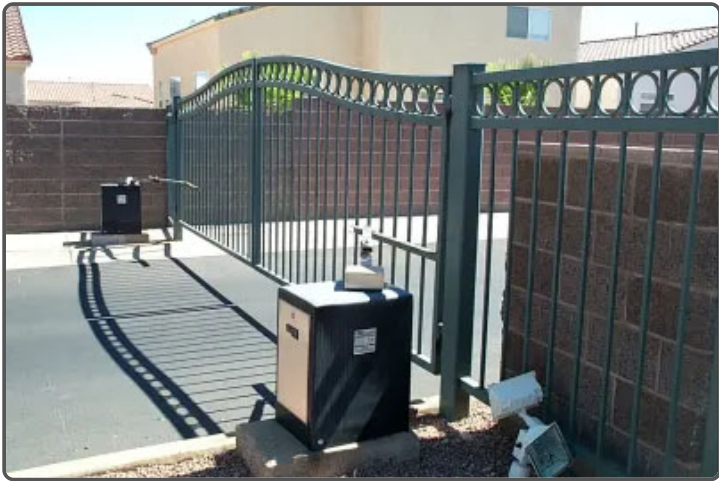
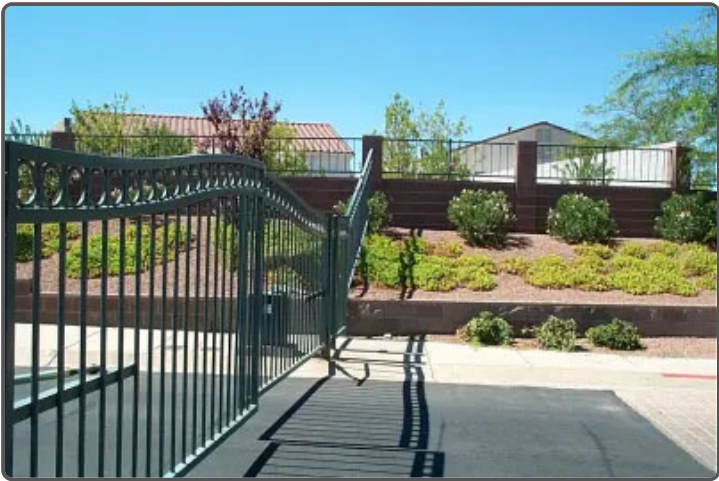
Comp # 504 Vehicle Gates - Replace

Although these gates may reach an extended life we recommend funding to completely replace them approximately every 30 years to ensure appearance and function. We have included funding for the replacement of the adjacent pedestrian gates and fencing at the same time.

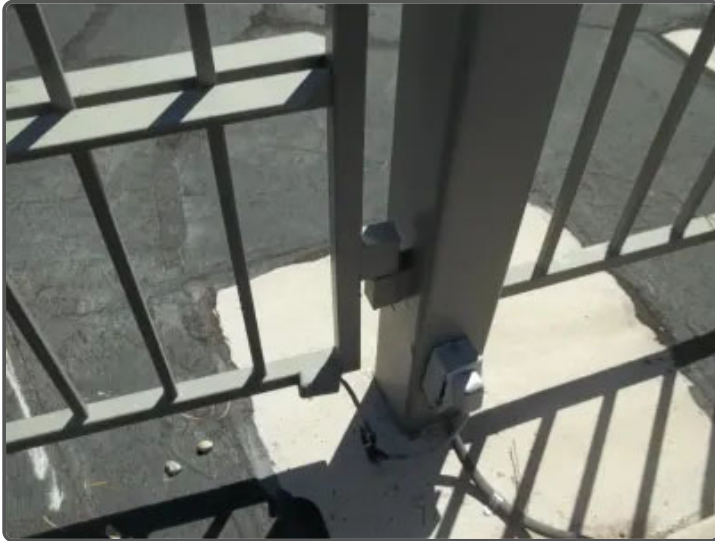
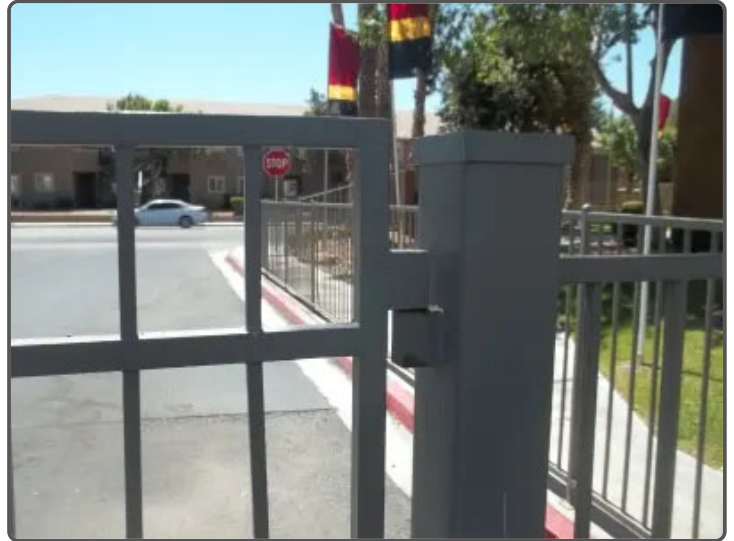
Comp # 505 Vehicle Gate Hinges - Replace

Although vehicle gates may reach an extended life the hinges will need to be periodically replaced to ensure proper function.

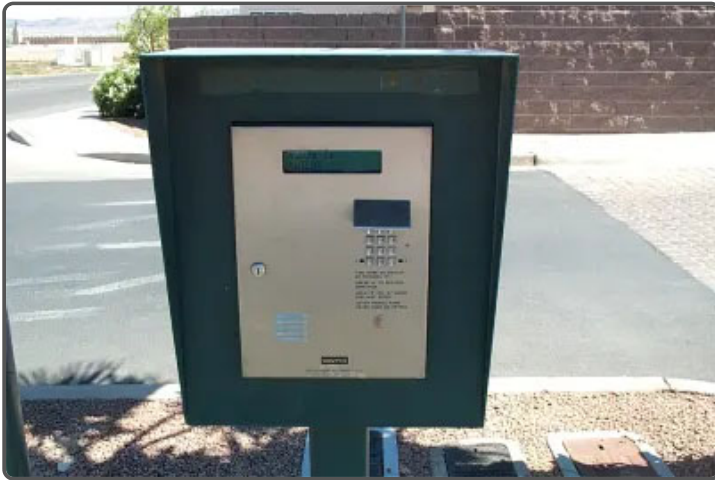
Comp # 506 Phone Entry System - Replace

No problems noted at the time of inspection. System was observed to be functioning normally. This type of system has a typical life expectancy of approximately 10 to 12 years. Remaining life based on current age and condition.

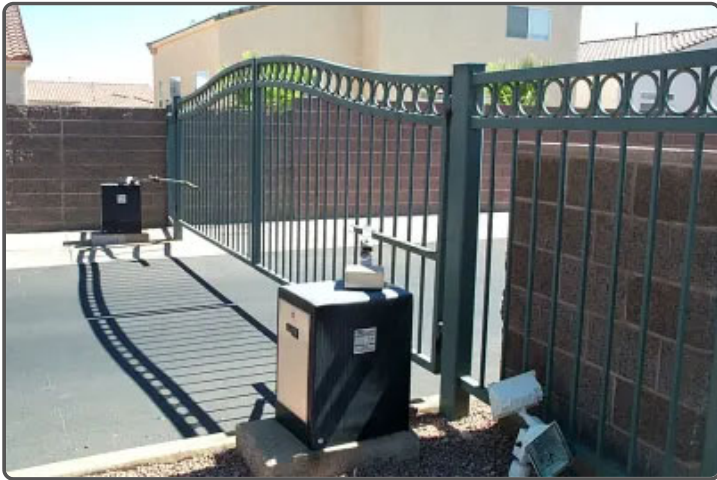
Comp # 507 Vehicle Gate Operators - Replace

Elite Access Systems
Model GSW-200-UL
1/2 HP, 125lbs Pull Rating
Serial #s:
06309851051
06309851051
06309851051
06309851051

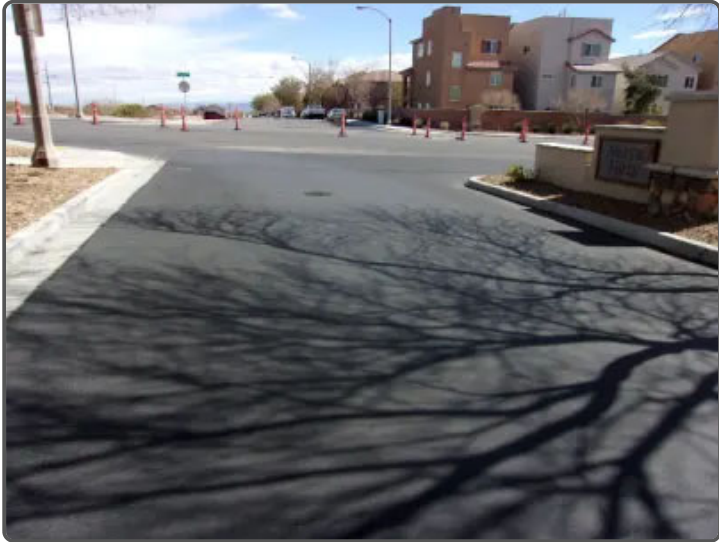
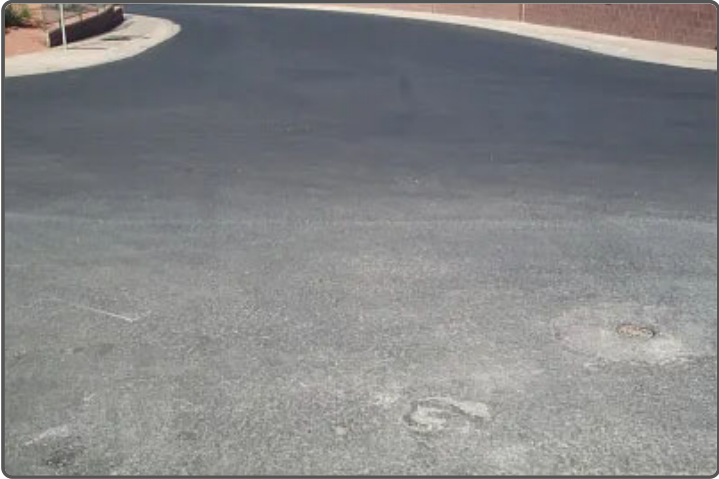
Comp # 508 Gate Loops - Replace

We recommend funding to replace gate loops approximately every 12 to 15 years to ensure proper function.

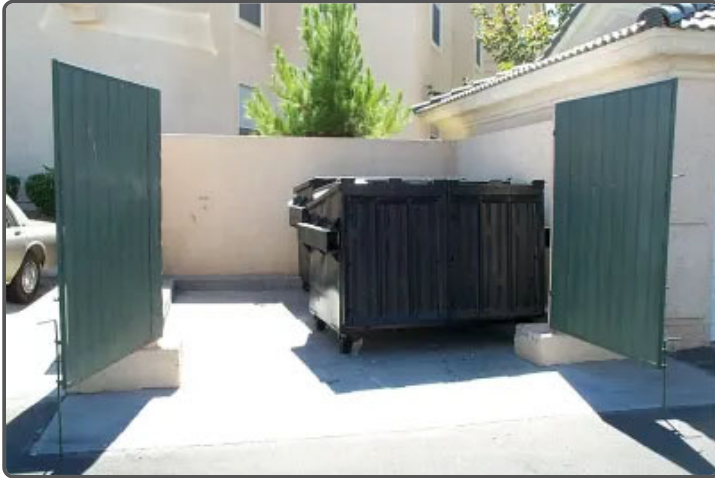
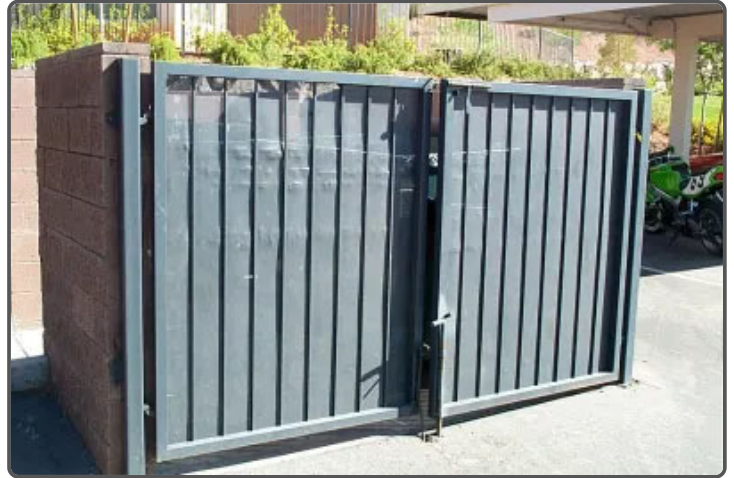
Comp # 590 Trash Enclosure Gates - Replace

- (1) 3 ft. Ped gate
- (2) 4.5 ft. Trash gates

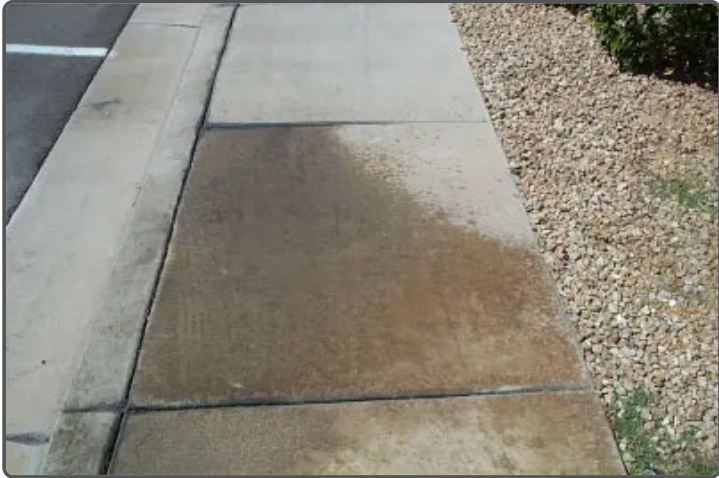
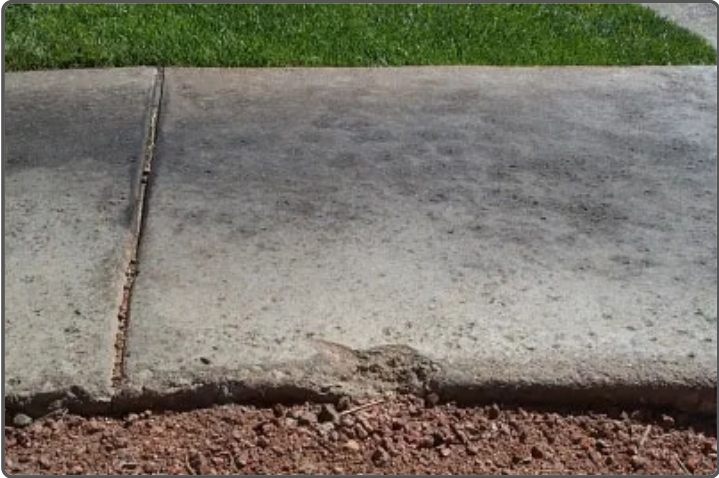
Comp # 601 Concrete Surfaces - Repair

Concrete walks are in good condition. No significant cracking or settling noted. Although concrete is not typically life limited, periodic repairs will be necessary to fix local cracking and settling.

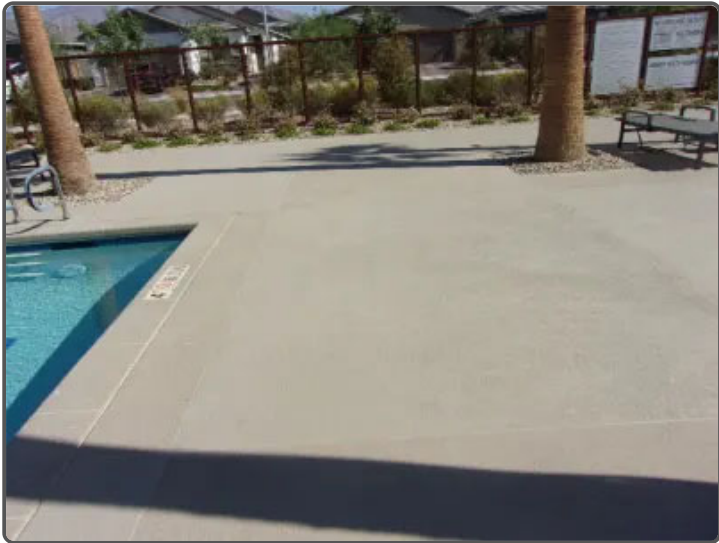
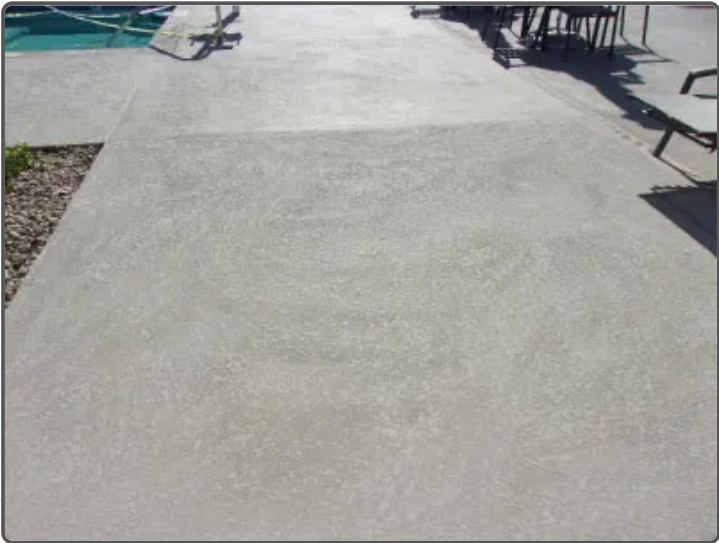
Comp # 603 Pool Deck - Reseal / Repair

Decks are in good condition. Seal these decks approximately every 5 years to protect deck surface and prevent premature deck resurface (see Comp# 604 Pool Deck - Resurface).

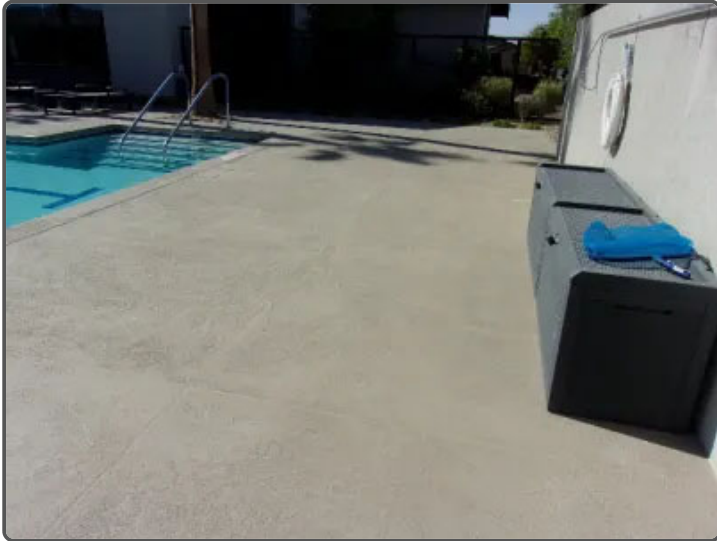
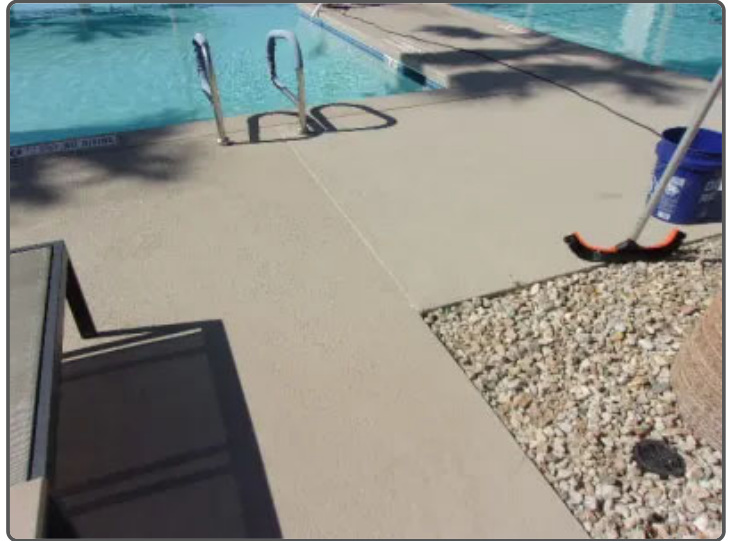
Comp # 604 Pool Deck - Resurface

Deck is in good condition. Expect to seal this component approximately every 5 years (see Comp# 603 Pool Deck - Reseal) and to completely resurface approximately every 20 years.

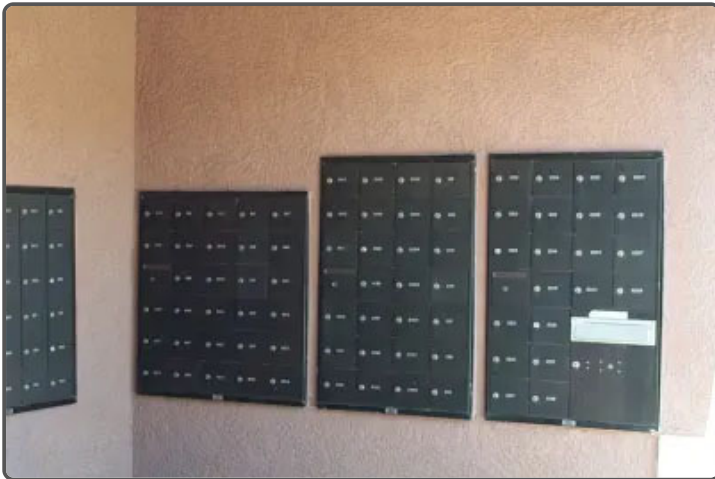
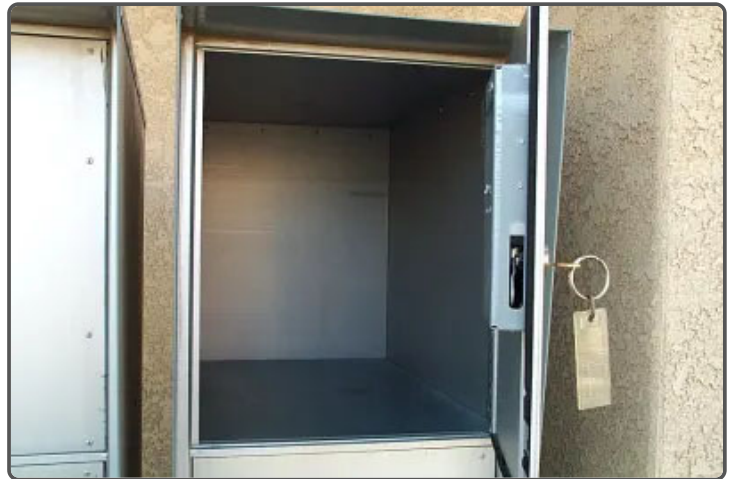
Comp # 803 Mailboxes - Replace

(6) 25-Box clusters

(7) Total clusters

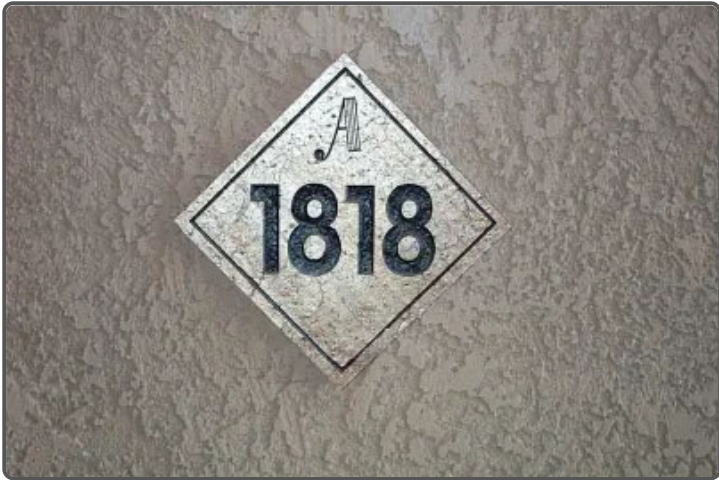
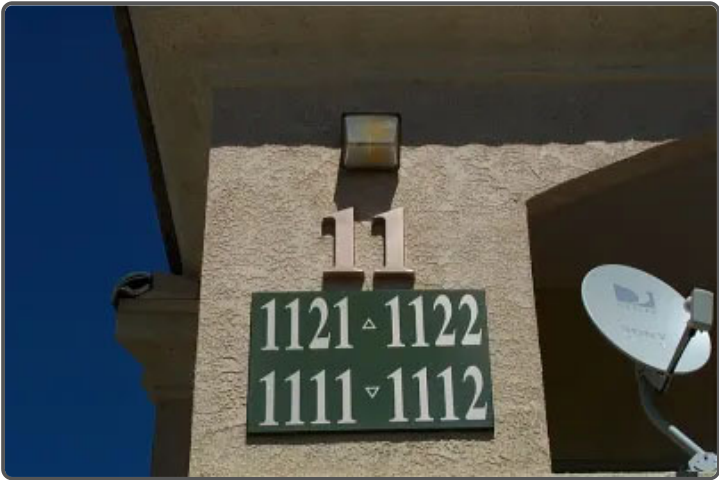
Comp # 805 Building Signs - Replace

Signs are in fair condition. No significant appearance or legibility concerns noted. Expect a typical useful life of approximately 15 to 20 years from these signs. Remaining life based on current condition.

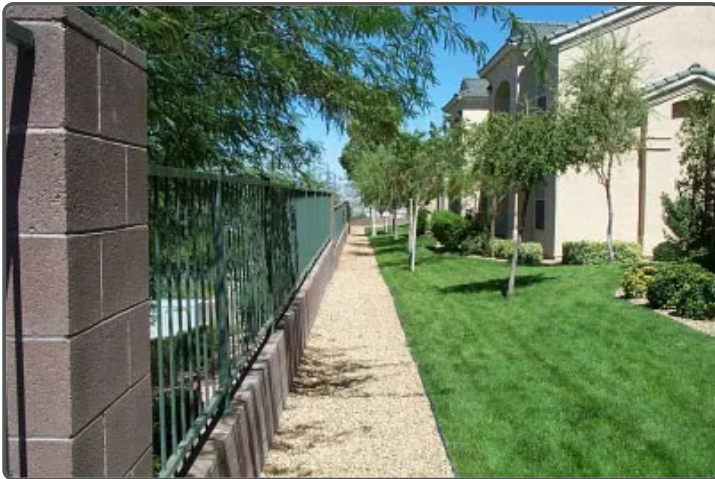
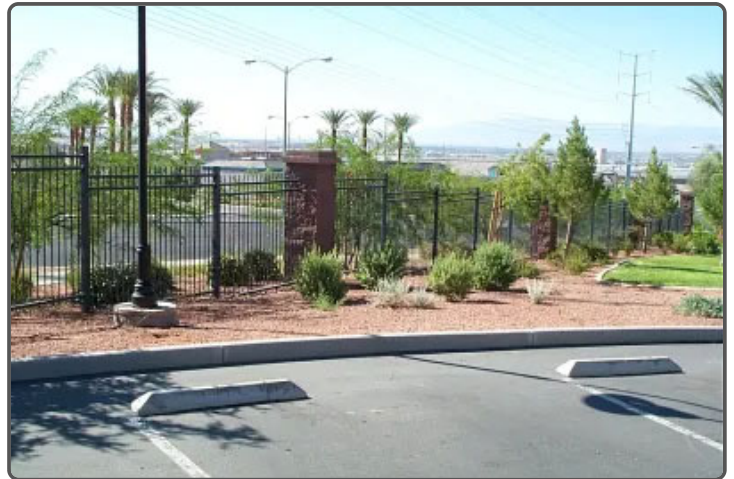
Comp # 1002 Wrought Iron Fencing - Repair/Replace

50 Linear ft. - Entry area
250 Linear ft. - Pool area
1,500 Linear ft. - Perimeter fencing
1,800 Linear ft. - Total

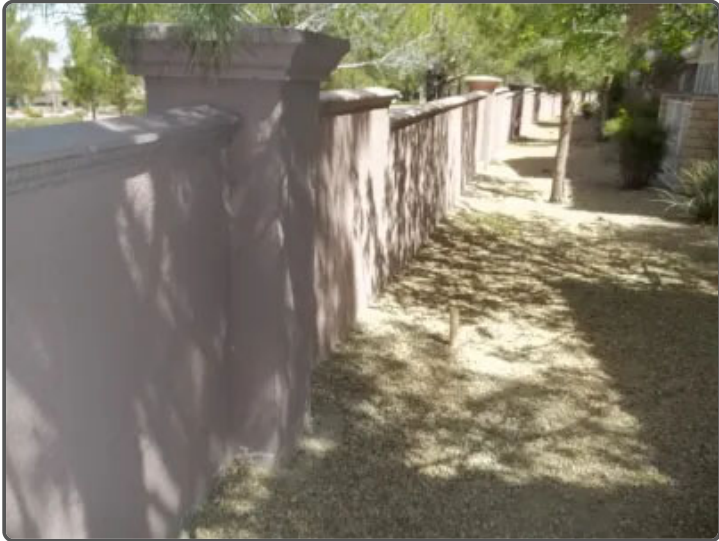
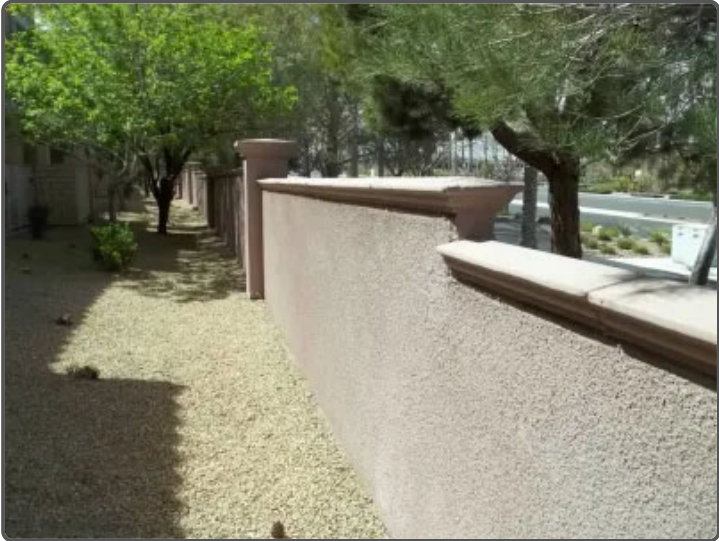
Comp # 1005 Block/Stucco Wall - Repair

No expectation to completely replace walls. Expect to make local repairs as necessary as an operating expense and funding for an allowance to make more significant repairs approximately every 20 years.

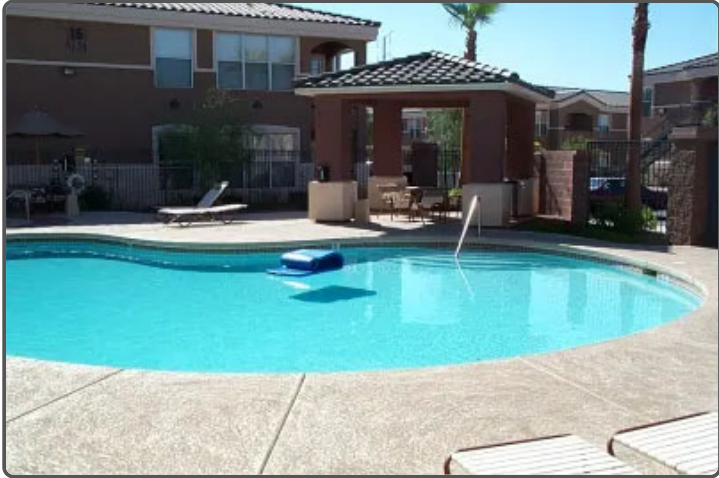
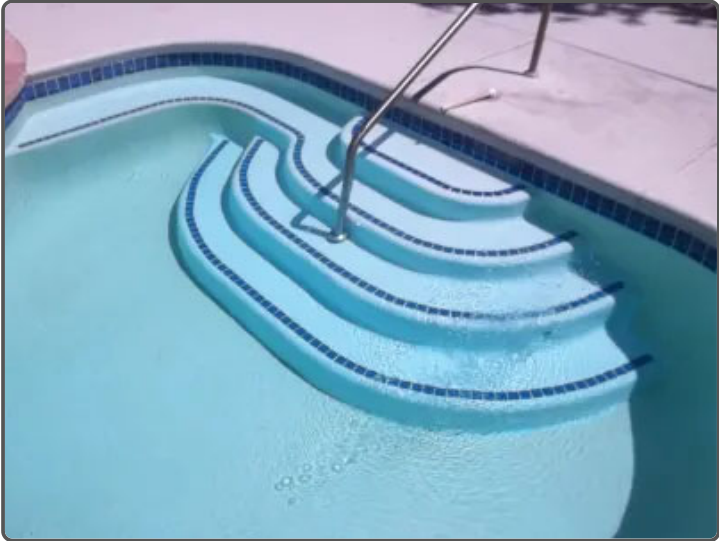
Comp # 1101 Pool - Resurface

Pool is generally in good to fair condition. Pool is approximately five years old. No significant cracking or surface loss noted. Pool plaster has a typical useful life of approximately 10 to 12 years assuming regular maintenance and normal wear.

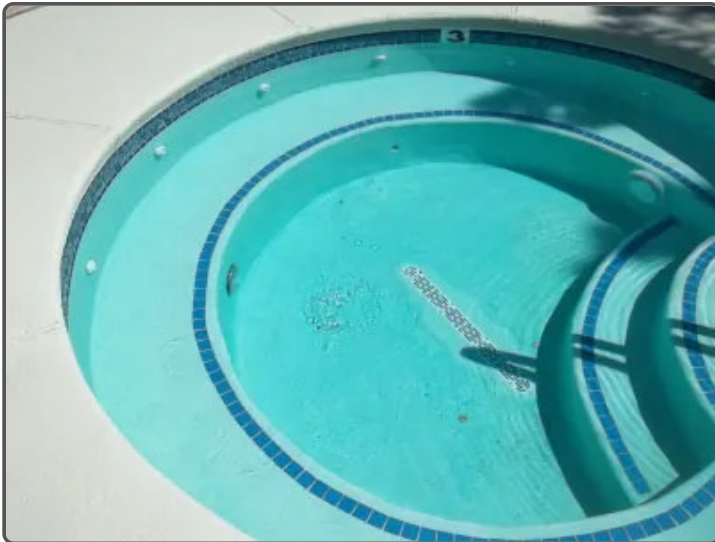
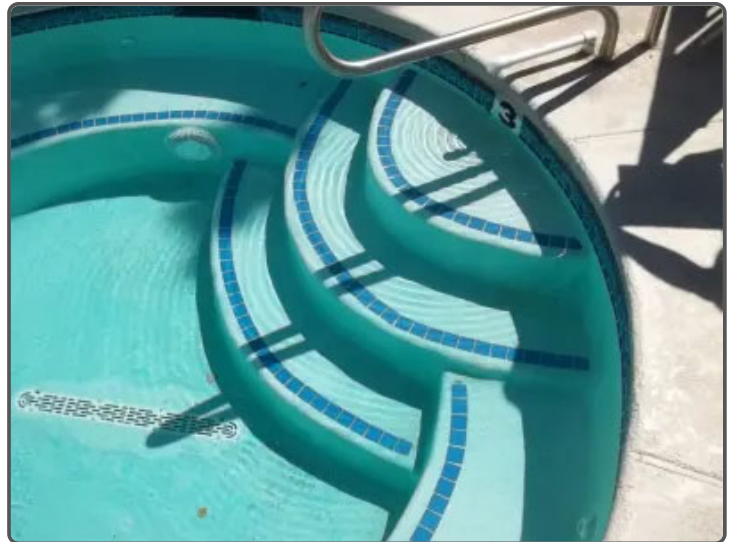
Comp # 1102 Spa - Resurface

Spa is in poor condition. Significant discoloration and surface loss noted at the time of site visit. With regular, professional maintenance expect a useful life of approximately 5 to 6 years from this component. Remaining life based on current condition.

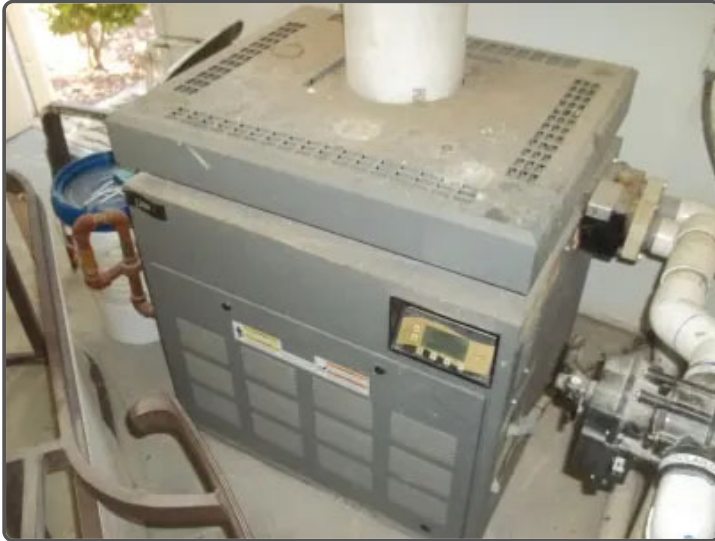
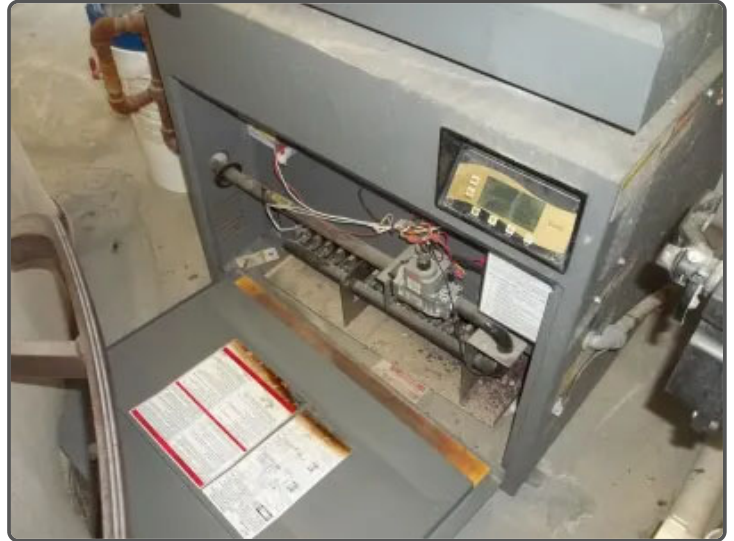
Comp # 1104 Pool Heater - Replace

Jandy Lite 2
Mod# LJ400NX
Ser# I06PK0394
400,000 BTU

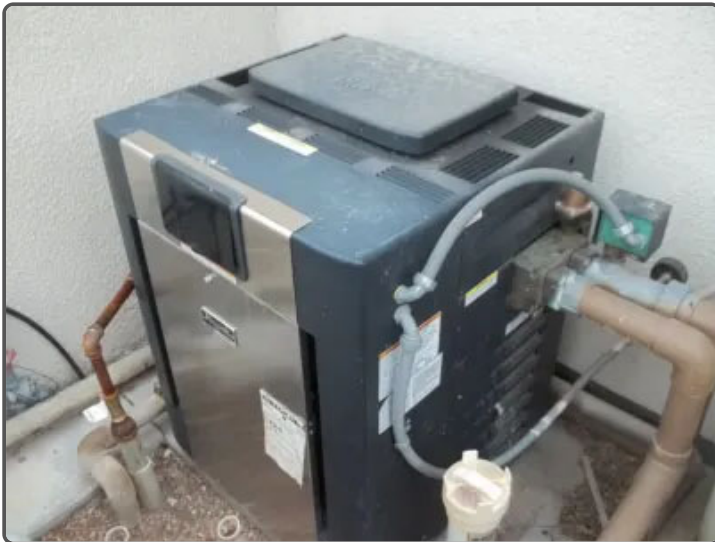
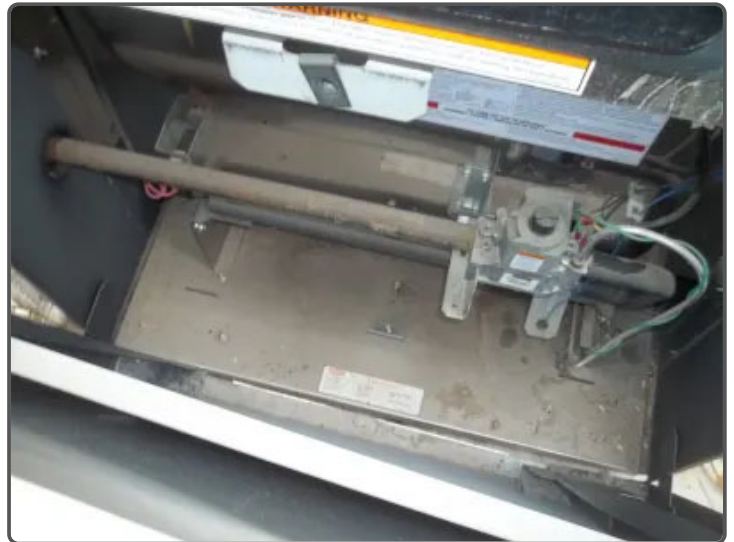
Comp # 1105 Spa Heater - Replace

Raypak Professional
Mod# B-R408-EN-X ASME
Ser# E 1202336316
399,000 BTU

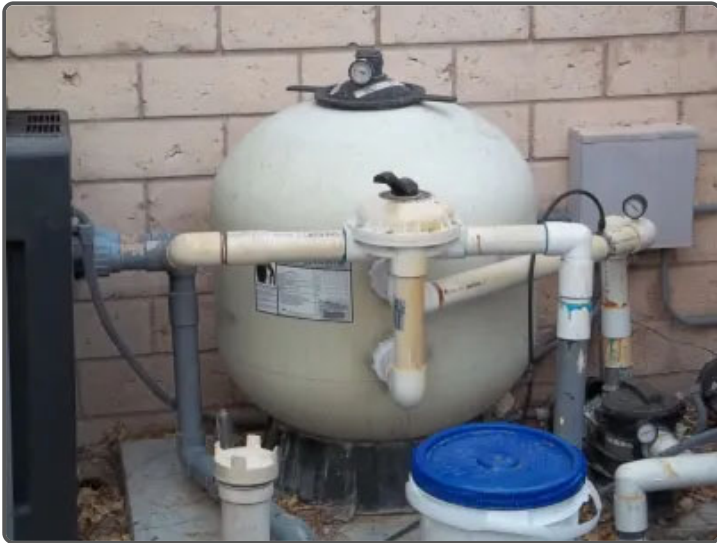
Comp # 1107 Pool Filter - Replace

Pool filter is in good to fair condition. No problems noted at the time of inspection. This type of pool filter has a life expectancy of approximately 12 years. Remaining life based on current age and condition.

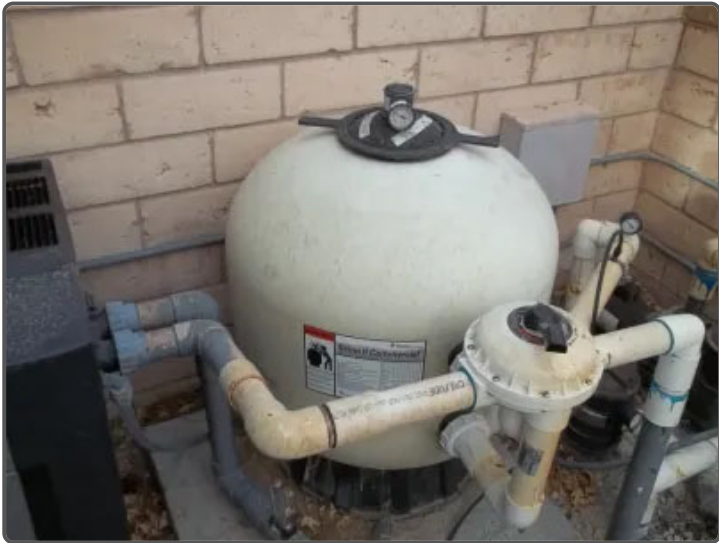
Comp # 1108 Spa Filter - Replace

Spa filter is in good condition. No evidence of significant leaks noted at the time of inspection. With regular maintenance expect a useful life of approximately 10 to 12 years from this component.

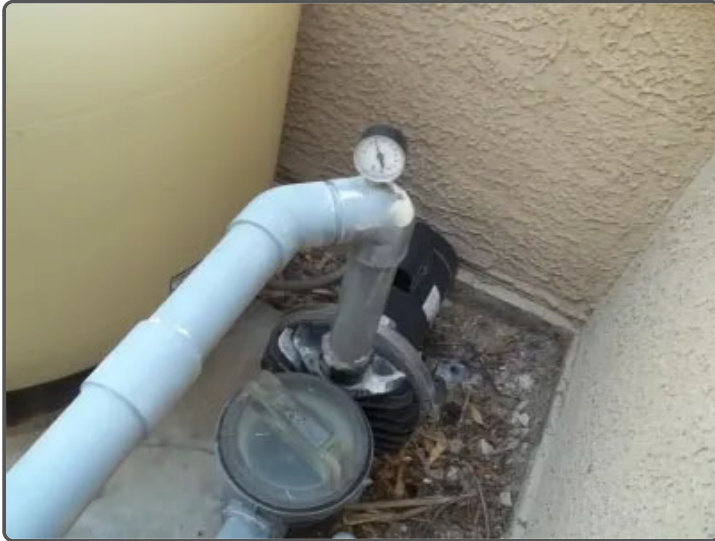
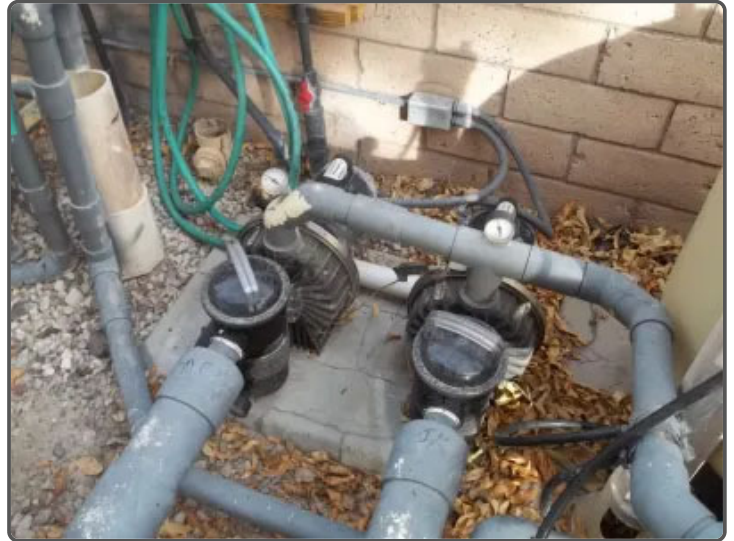
Comp # 1110 Pool/Spa Pumps - Partial Replace

(1) 1.5 HP pump

(3) Total pumps

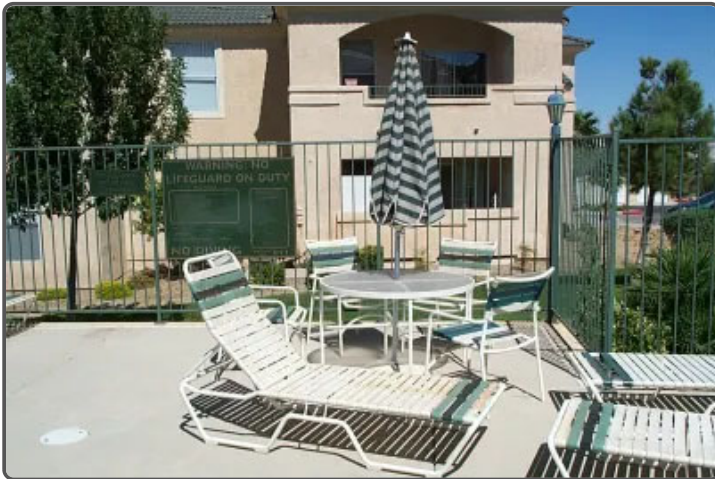
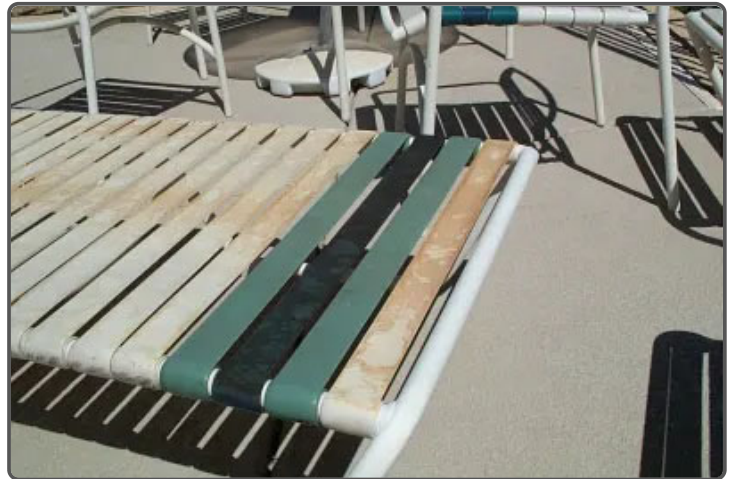
Comp # 1120 Pool Furniture - Replace

- (8) Chaise Lounges
- (5) Chairs
- (3) Glass-Top Tables
- (3) Umbrellas
- (4) Drink Tables

(23) Pieces

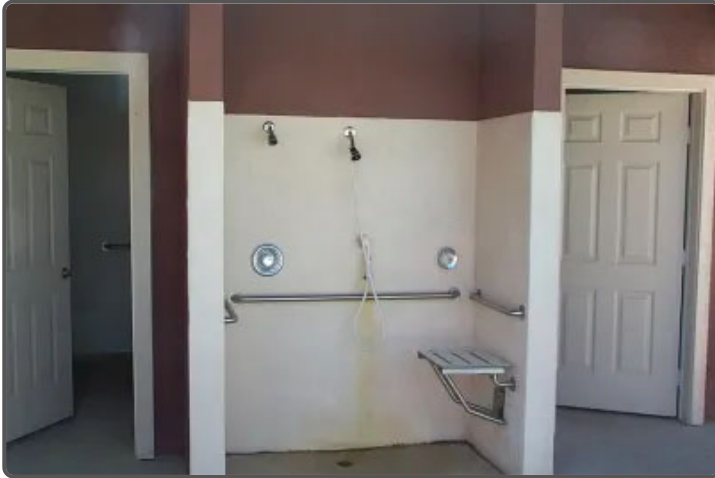
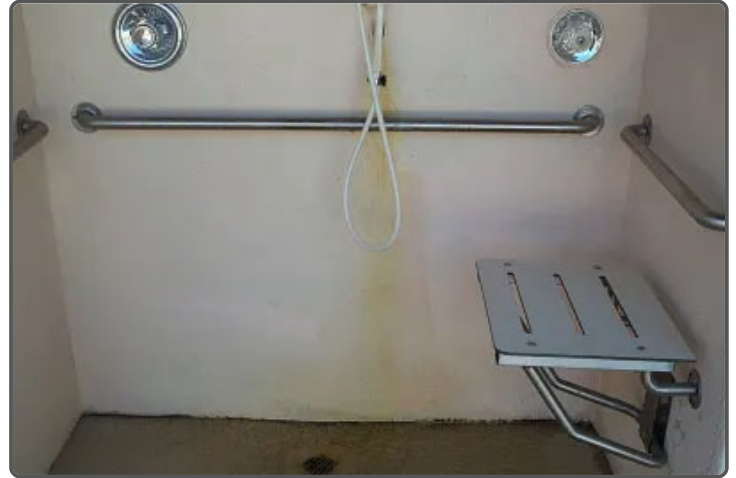
Comp # 1390 Outdoor Shower - Re-Tile

No broken or missing tiles noted, no grout problems observed. We recommend funding to re-tile this shower approximately every 15 to 20 years to ensure appearance and function.

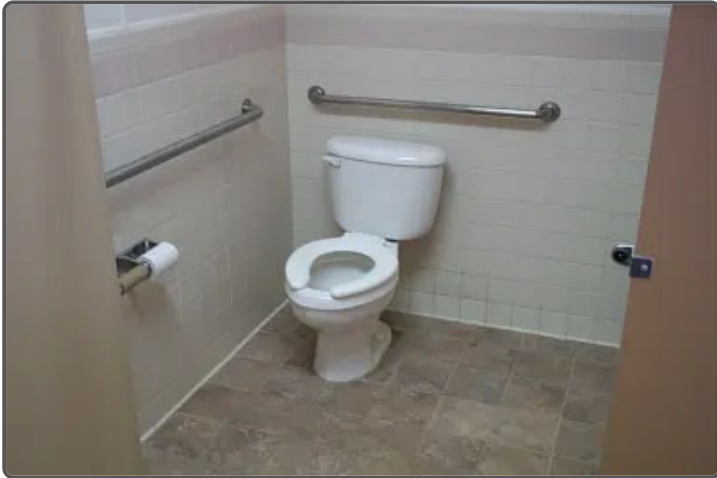
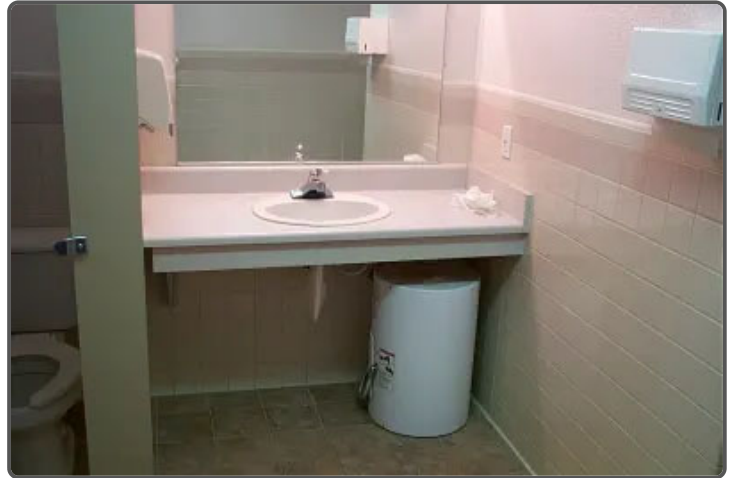
Comp # 1413 Restrooms - Remodel

Restrooms are in good condition. No appearance concerns noted at the time of inspection. We recommend funding to generally remodel and refurbish these restrooms approximately every 15 to 20 years to maintain appearance and keep up with current decorative tastes.

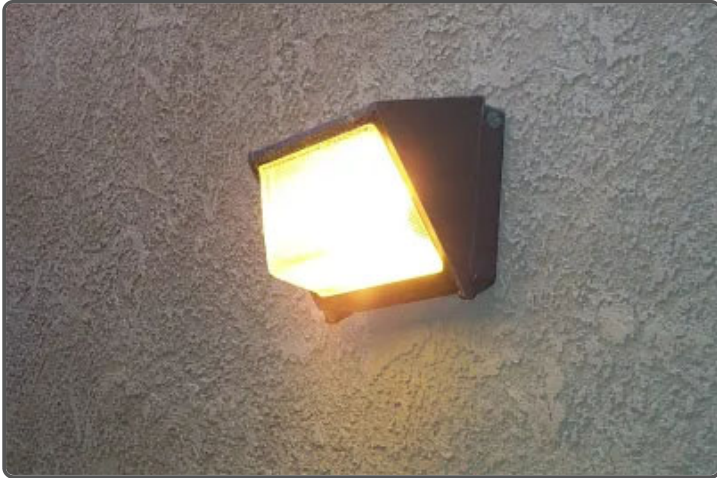
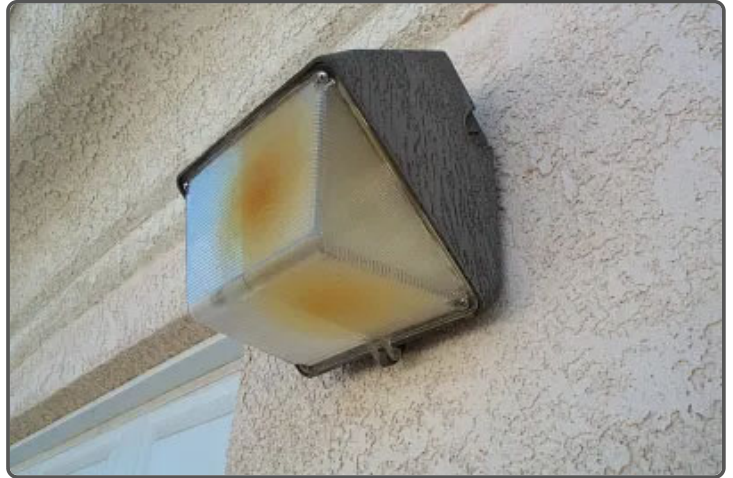
Comp # 1602 Exterior Wall Mount Lights - Replace

Lights are generally in good condition. No significant pitting or discoloration noted. Expect to replace these lights approximately every 16 years to maintain appearance. Remaining life based on current age and condition.
