Sample Community Association

Level 1 Reserve Study

Client Reference Number	10014
Property Type	Condominium
Number of Units	150
Fiscal Year End	12/31
Type of Study	Full Study
Date of Site Visit	4/16/2023
Prepared By	Robert Forney
Analysis Method	Cash Flow
Funding Goal	Full Funding

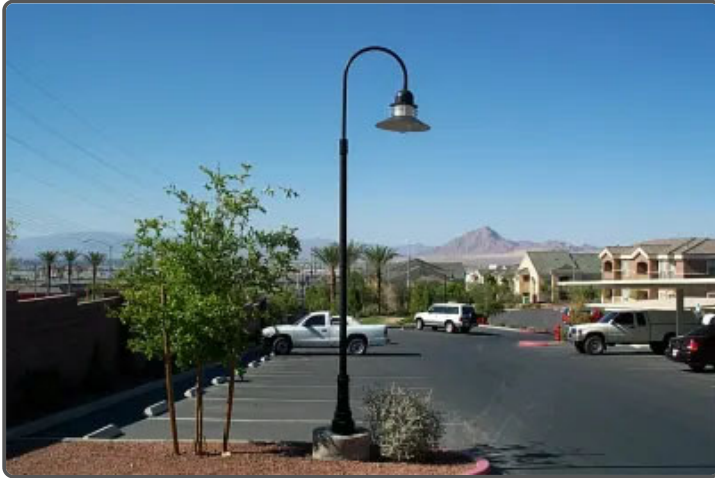
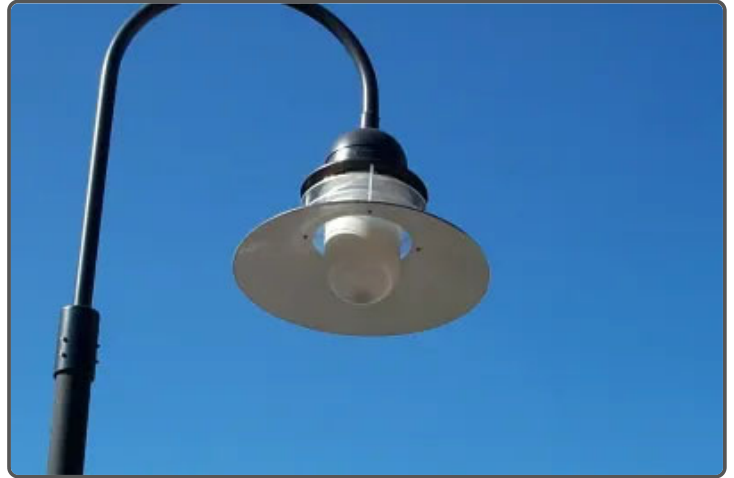
Comp # 1604 Pole Light Fixtures - Replace

Globes are in fair condition. Due to minimal replacement cost, replace plastic globes as necessary as an operating expense. Light poles have an extended life, no expectation to replace poles. No reserve funding necessary.

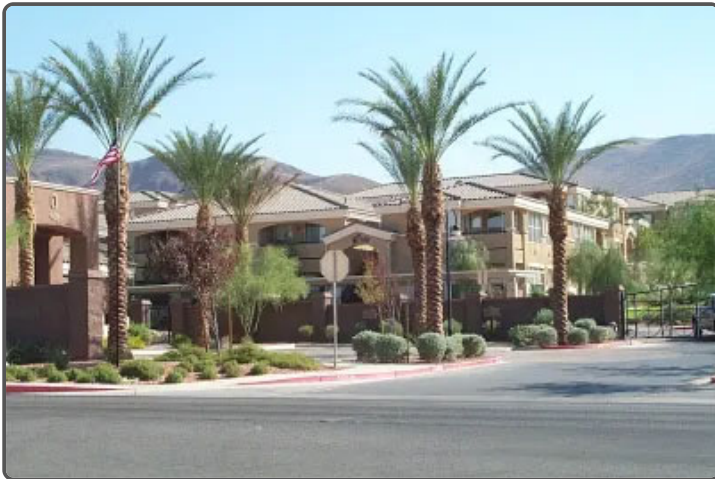
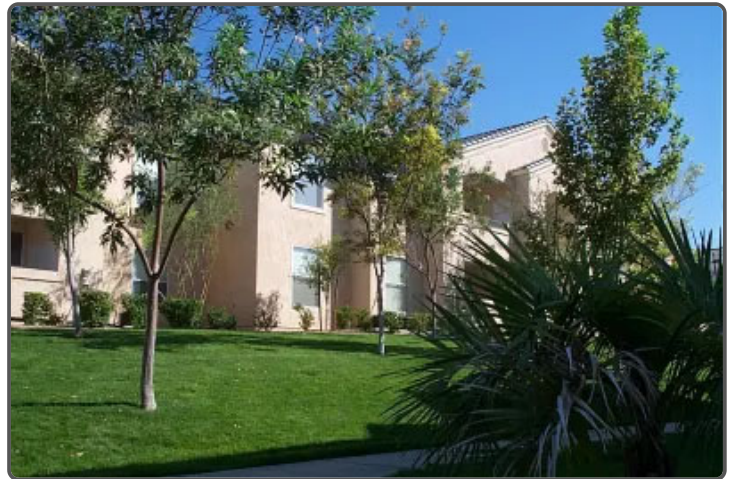
Comp # 1813 Landscaping / Irrigation - Major Renovate

We recommend funding for an allowance for a major project to the landscaping infrastructure including significant and/or total irrigation replacement approximately every 20 years. This allowance should be re-evaluated in future Reserve Studies as the community ages and the property develops a history of repairs, landscaping upgrades, etc.

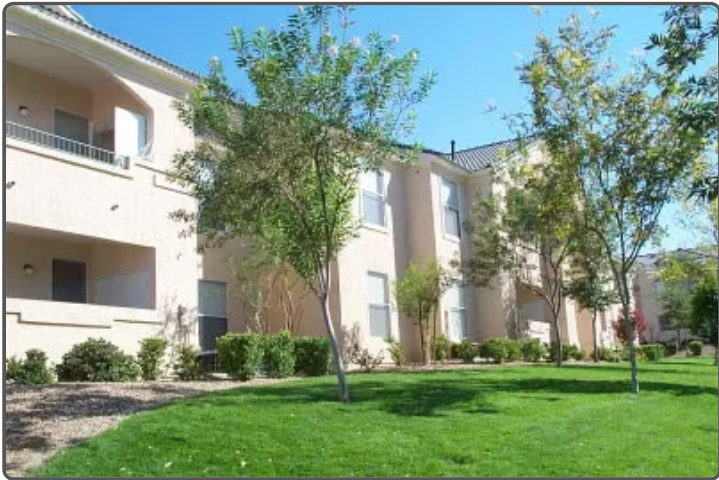
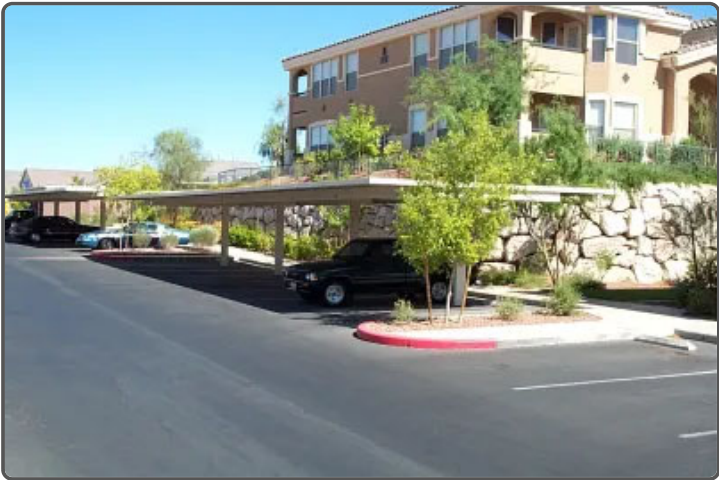
Comp # 1814 Landscaping / Irrigation - Minor Renovate

No expectation to completely re-landscape the community. We recommend funding for an allowance to make repairs to the irrigation system, landscape lighting, and to generally renovate the landscaping approximately every 5 years.
