# Sample Community Association

## Level 1 Reserve Study

**Report Period – 1/1/2013 – 12/31/2013**

## Executive Summary – Sample Community Association - ID # 10014

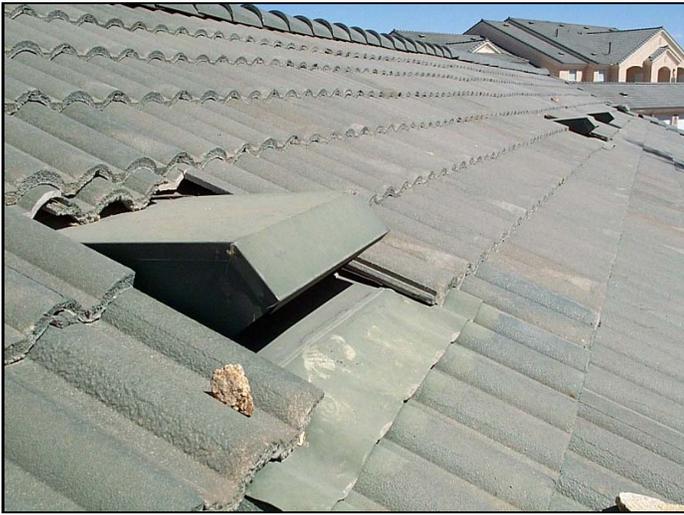
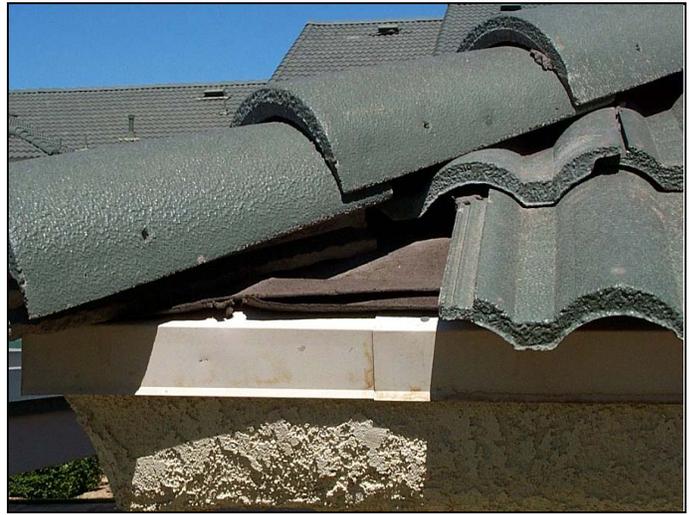
Comp #: 106 Pitched Roof - Tile - Replace

No problems noted or reported. Tile roofs have a typical life expectancy of approximately 25 to 30 years before underlayment deterioration causes significant leaks. Remaining life based on current age.

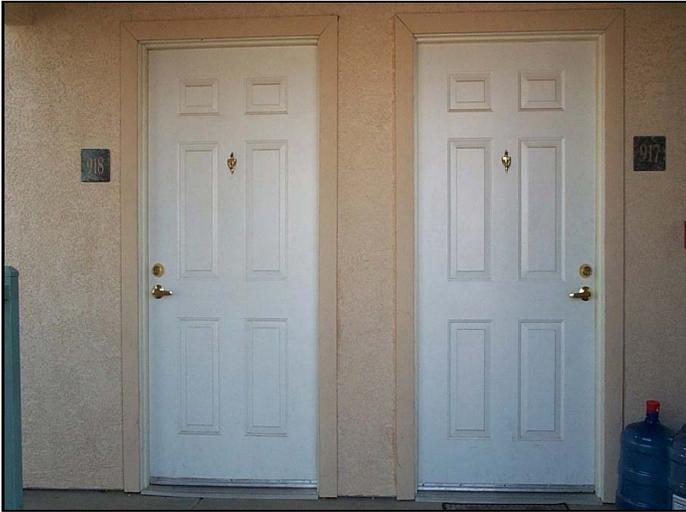
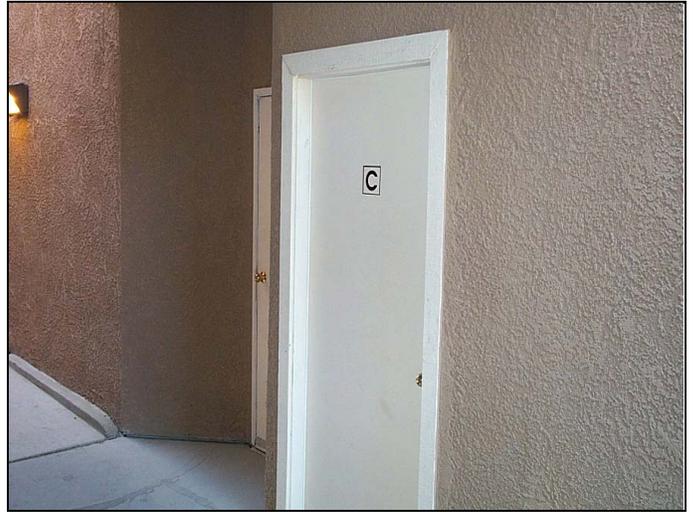
Comp #: 204 Front Doors - Repaint

Significant scuffing and marking noted on doors. Due to age and current condition, repaint doors this fiscal year to improve appearance and protect wood surfaces. Expect to repaint doors every 5 to 6 years to maintain appearance and protect wood.

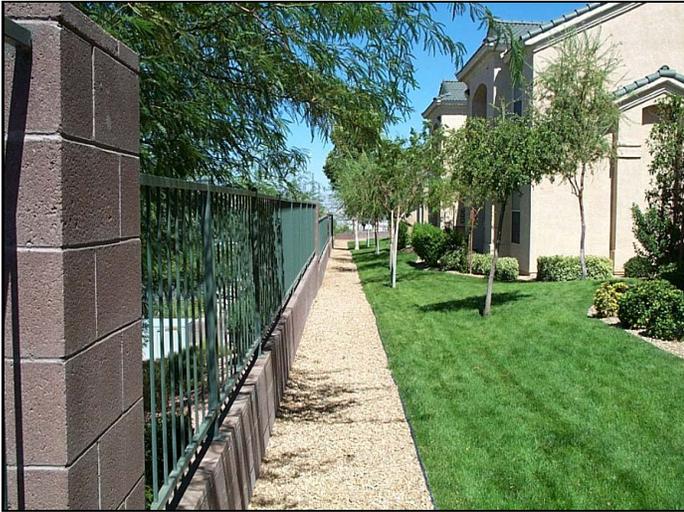
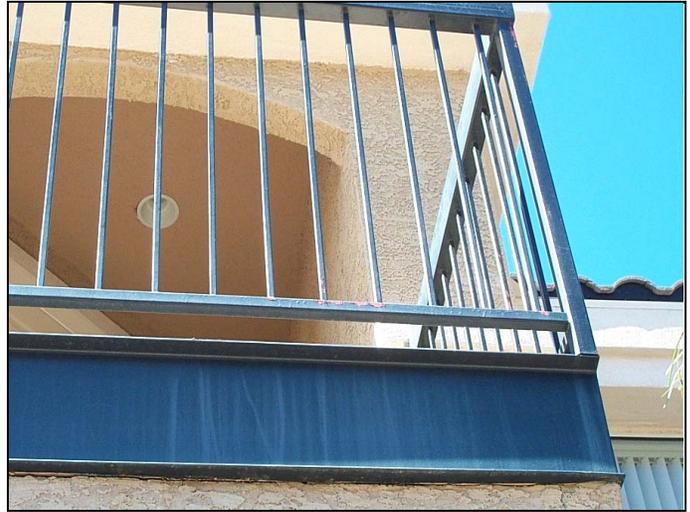
Comp #: 207 Iron Fencing - Repaint

Minor rusting noted in local areas. No significant deterioration or broken welds noted. Touch-up problem areas immediately as an operating issue and repaint all fencing approximately every 5 years to ensure full useful life from this component. Remaining life based on current condition.

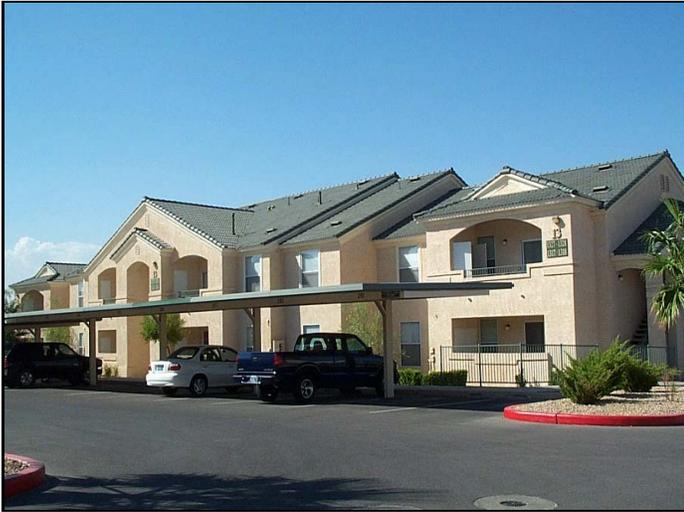
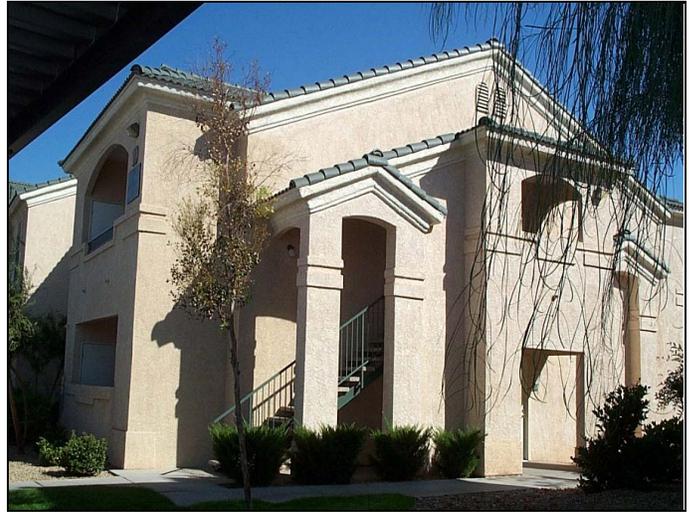
Comp #: 217 Stucco Building Surfaces - Repaint

Minor staining in local areas. Generally, painted surfaces are in good condition, assume surfaces will reach a full useful life of approximately 10-12 years. Remaining life based on current age and condition.

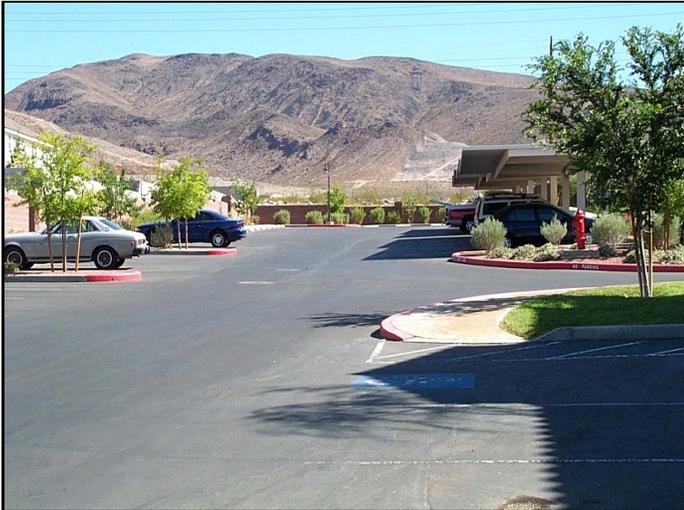
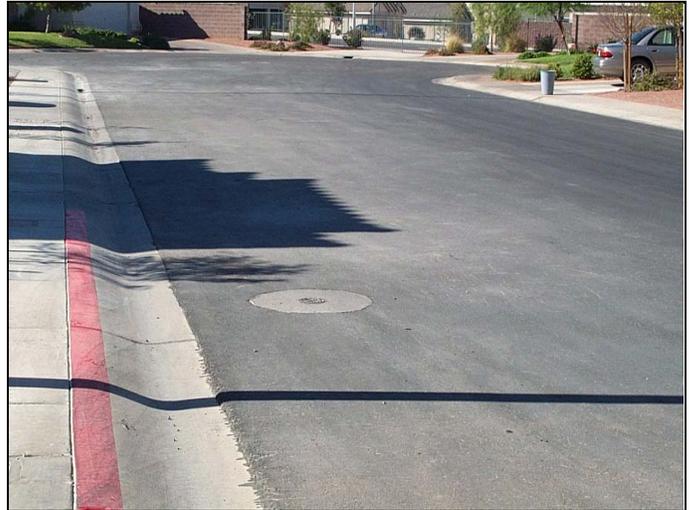
Comp #: 401 Asphalt - Overlay

Asphalt surface is in good condition. No potholes or other damage to surface noted. With proper maintenance, expect a useful life of 20 to 25 years from this component. Seal regularly to protect asphalt surface.

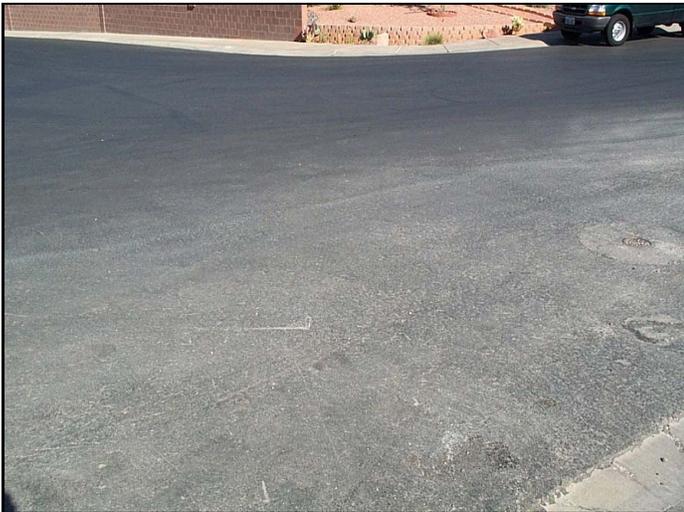
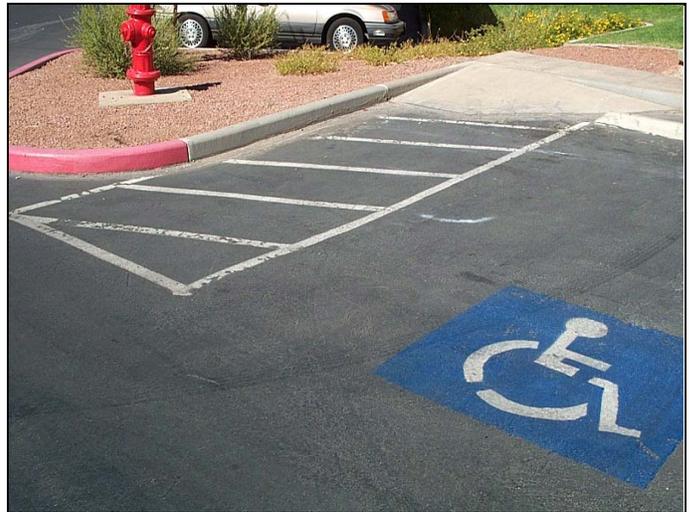
Comp #: 402 Asphalt - Seal

Asphalt seal coat is in fair to poor condition. Minor deterioration and loss of seal noted in local areas throughout. Asphalt surfaces should be sealed approximately every 5 years to prevent damage to asphalt surface and ensure full asphalt life. Seal asphalt surfaces this year based on age and current condition.

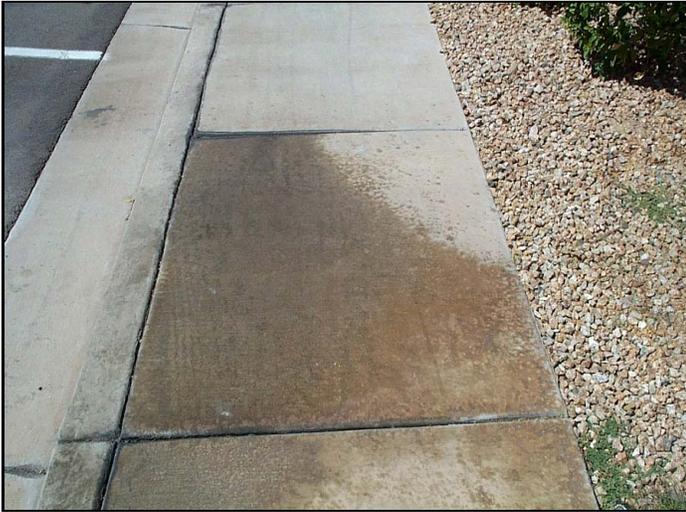
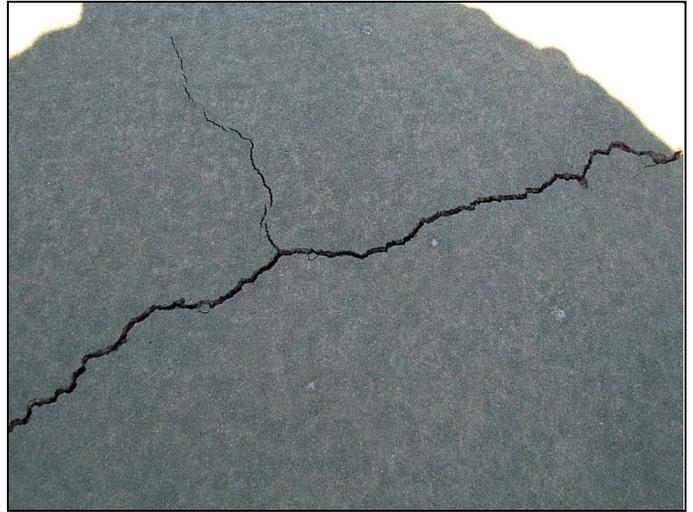
Comp #: 403 Concrete - Repair/Replace

No significant problems noted at the time of inspection. Some minor cracking noted in local areas, no significant lifting or settling observed. Concrete surfaces typically have an indefinite useful life, no expectation to completely replace these surfaces at one time. Make local repairs as necessary as an operating issue. No reserve funding necessary.

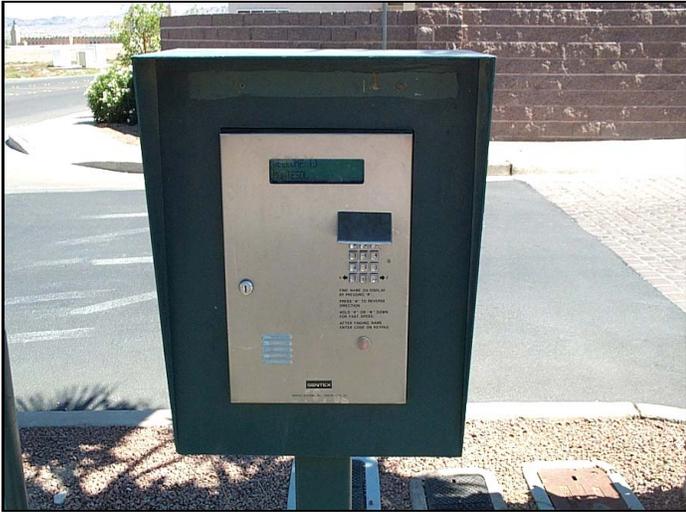
Comp #: 506 Phone Entry System - Replace

*Location:* **Community entrance**

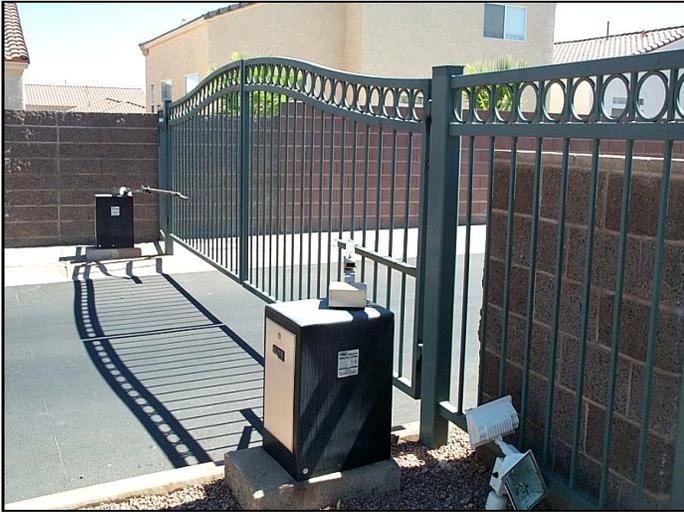
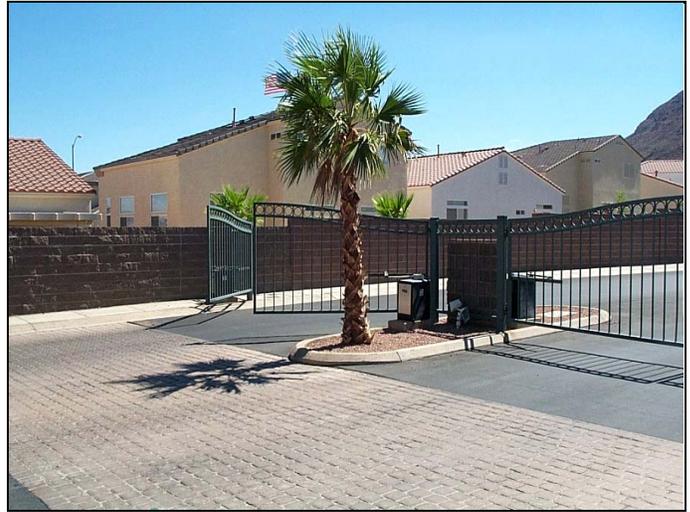
Comp #: 507 Vehicle Gate Operators - Replace

Gate operators are in good condition with no reports of problems. Expect a typical useful life of approximately ten years from this component.

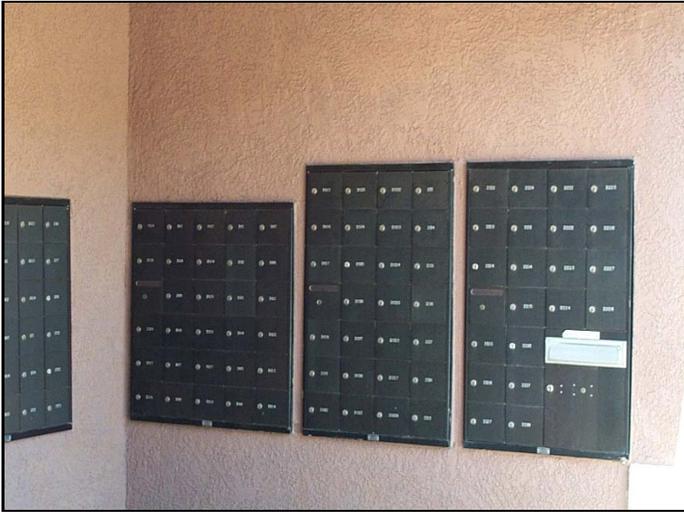
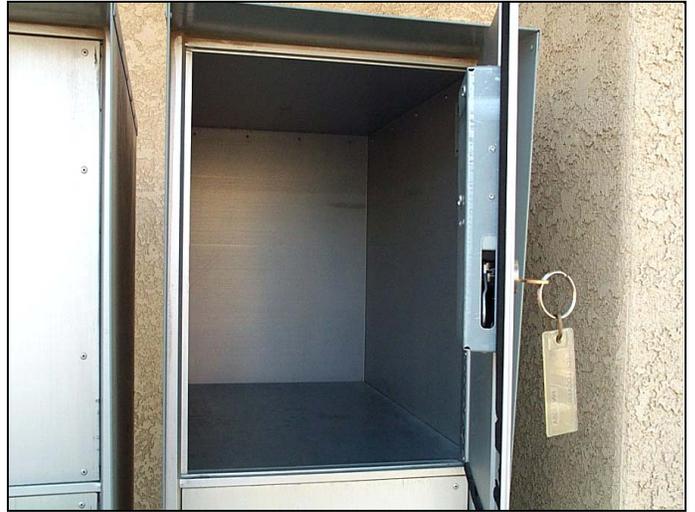
Comp #: 803 Mailboxes - Replace

Mailboxes are generally in good condition. No rust or deterioration noted, no broken doors or hinges observed. Boxes are covered and well protected from the elements. Expect these mailboxes to reach a full useful life of approximately 18 to 20 years.

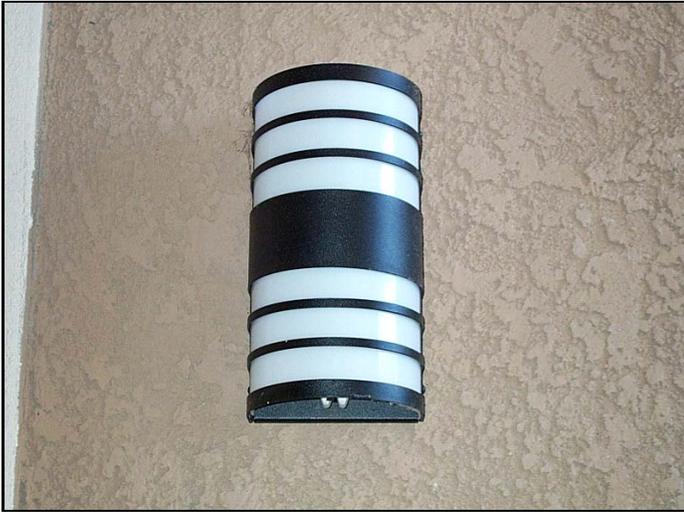
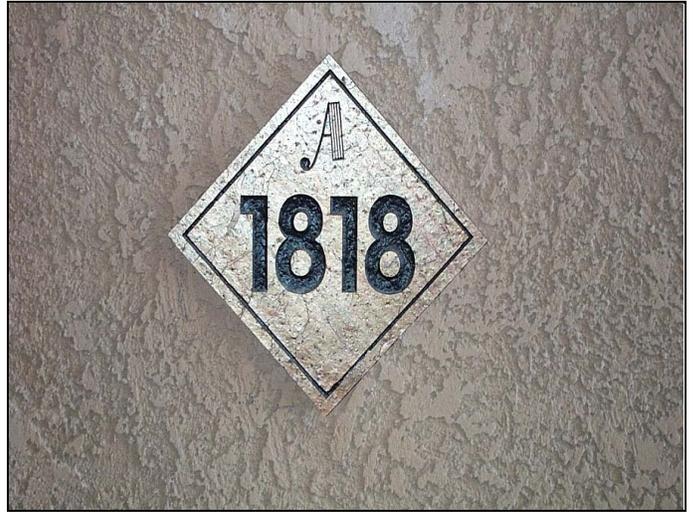
Comp #: 806 Unit Entry Hardware - Replace

Entry to each unit includes (1) decorative lamp and (1) unit number sign. Lamps and signs are currently in good condition. Expect a useful life of approximately 15 to 18 years from this component.

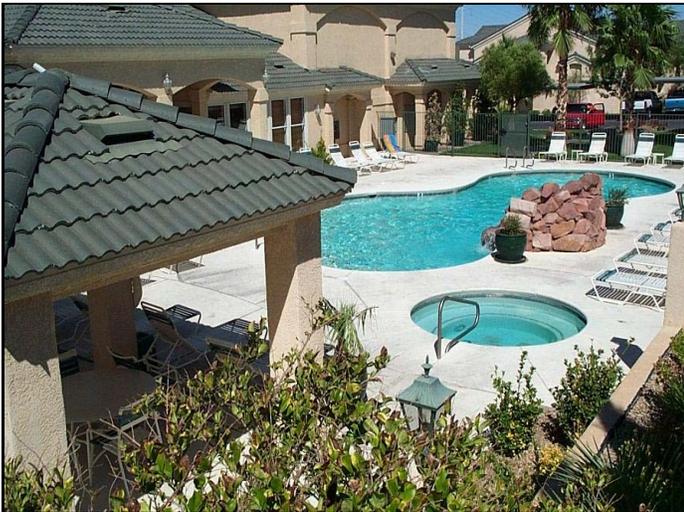
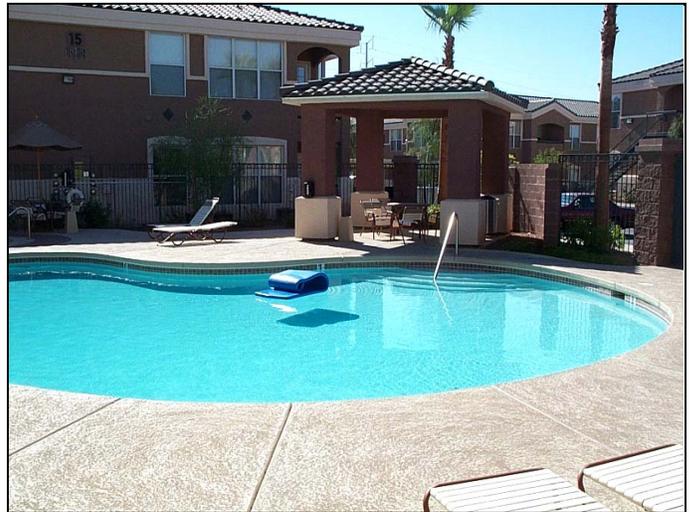
Comp #: 1101 Pool - Resurface

Pool is generally in good to fair condition. Pool is approximately five years old. No significant cracking or surface loss noted. Pool plaster has a typical useful life of approximately 10 to 12 years assuming regular maintenance and normal wear.

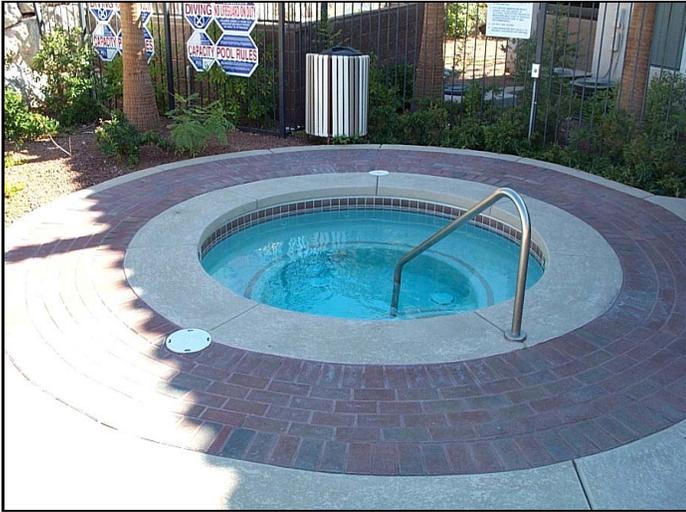
Comp #: 1102 Spa - Resurface

*Location:* Pool/Spa area

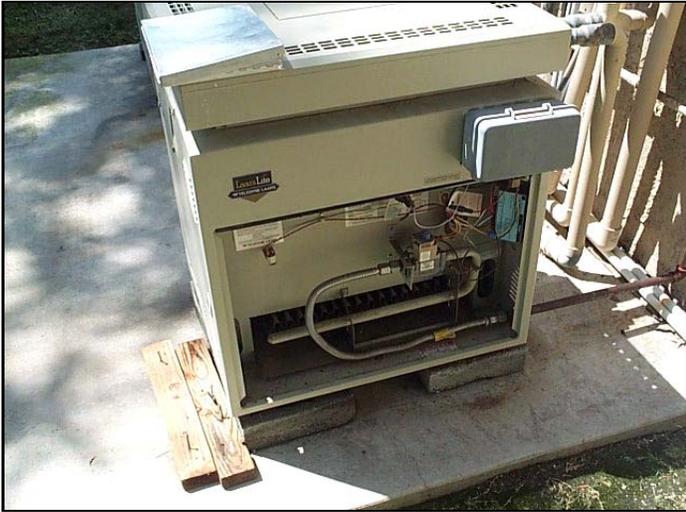
Comp #: 1104 Pool Heater - Replace

*Location:* **Pool equipment area**

**(1) Teledyne Laars Lite Pool Heater**  
**Serial # 12118764**  
**400,000 BTU**

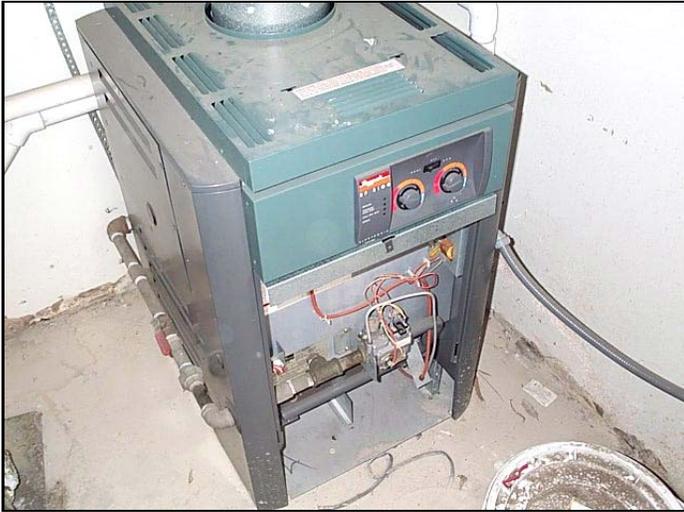
Comp #: 1105 Spa Heater - Replace

*Location:* **Pool equipment area**

**(1) Raypak Heater  
250,000 BTU  
Serial # 9411119392**

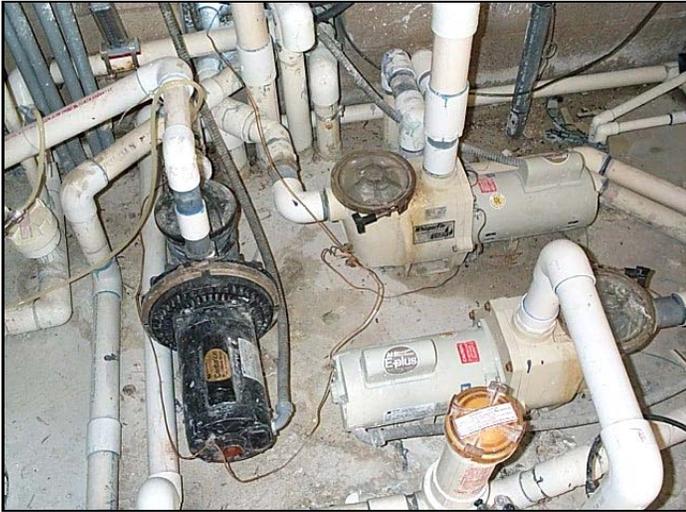
Comp #: 1110 Pool/Spa Pumps - Partial Replace

*Location:* **Pool equipment area**

**(3) Total pumps**

1110	Pool/Spa Pumps - Partial Replace	3	1	\$900	\$300	0.8271%
1120	Pool Furniture - Replace	6	1	\$5,000	\$833	2.2975%
1604	Pole Lights - Replace	18	12	\$30,625	\$1,701	4.6907%
1703	Irrigation Time Clocks - Partial Replace	3	1	\$1,700	\$567	1.5623%

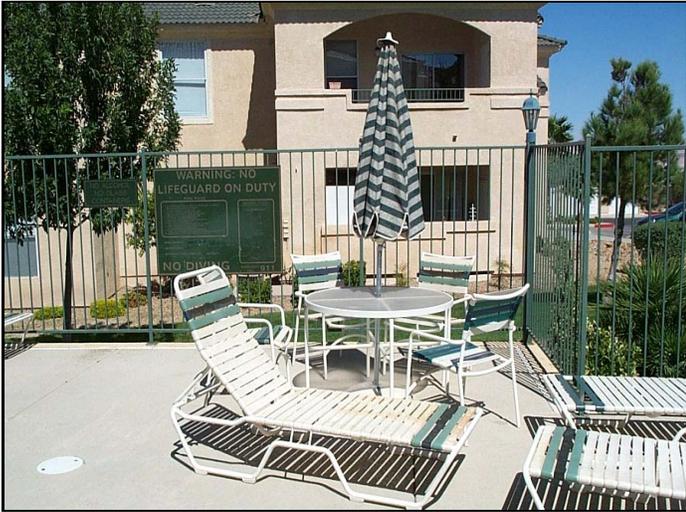
Comp #: 1120 Pool Furniture - Replace

*Location:* **Pool area**

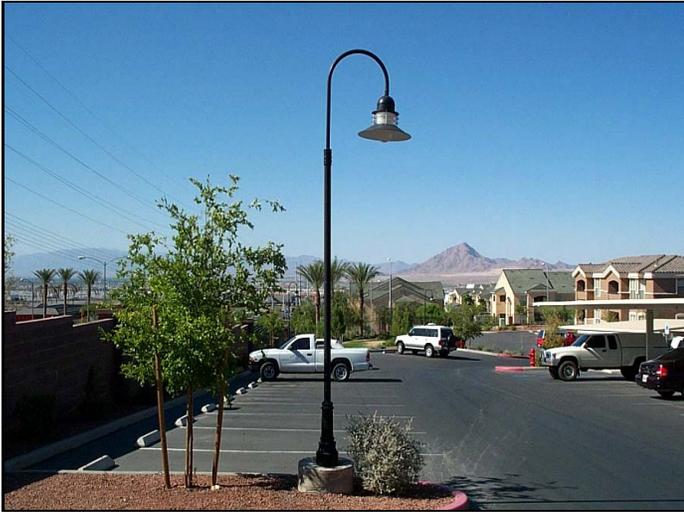
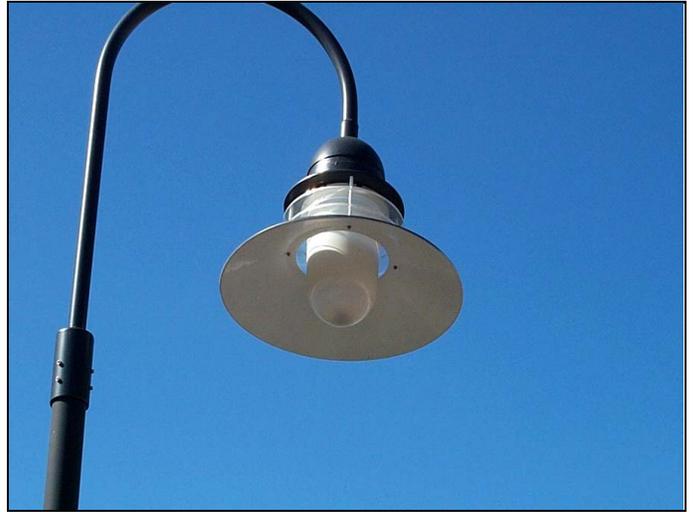
Comp #: 1604 Pole Lights - Replace

Light poles have an indefinite useful life, no expectation to replace light poles. Expect to replace heads every 15 to 20 years. Repaint heads and poles regularly as an operating issue to protect metal surfaces and maintain appearance.

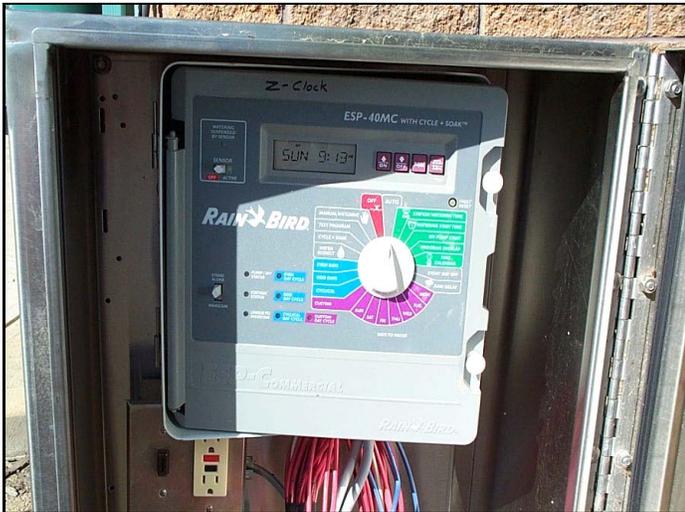
Comp #: 1703 Irrigation Time Clocks - Partial Replace

*Observations:*  
No expectation to replace all clocks at one time. We recommend funding to replace two clocks approximately every three years.
